# Roof Condition Report

Documentation, Analysis and Recommendations for  
the Standing Seam Metal and EPDM Roof Assemblies

Carroll County  
Annex Building  
10 County Farm Rd  
Ossipee, NH 03864

June 26, 2024

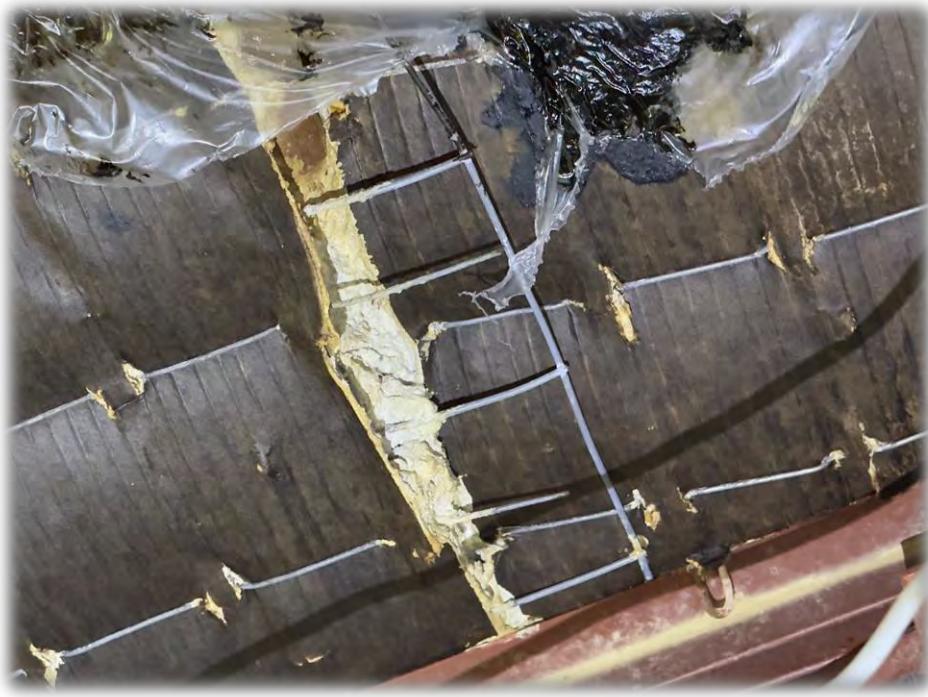
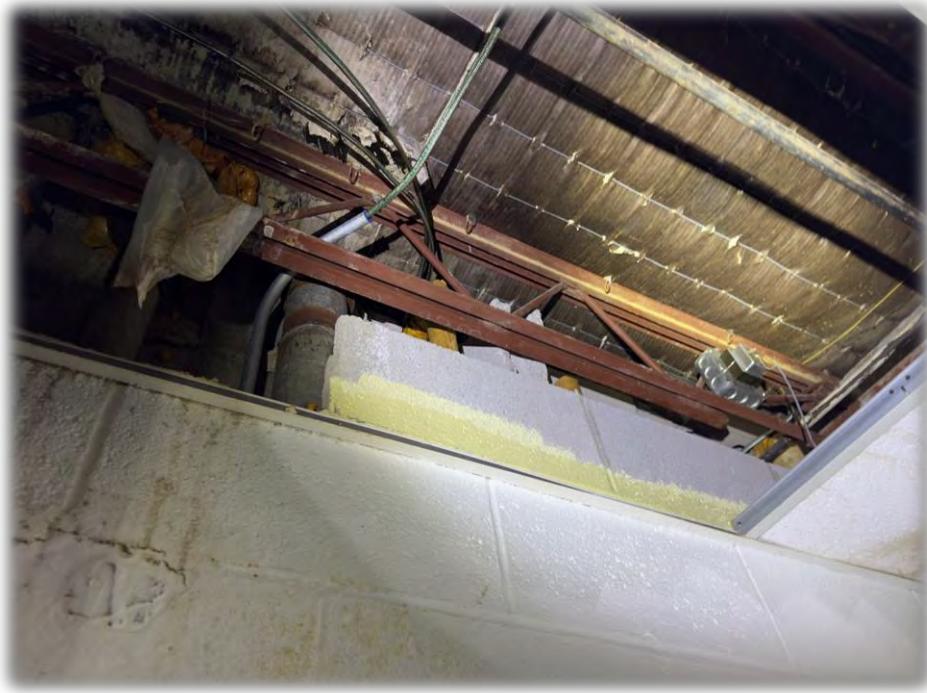
**Concrete Roof Deck** panels were noted in service beneath the standing seam metal roof areas of the Annex building, comprised of a wire reinforced thing form panel beneath the deck panels as seen in the series of photographs #14 through 18. These panels were set on the top chords of the bar joists and held in place with periodic heavy wire clips seen in photographs # 15 and 16.

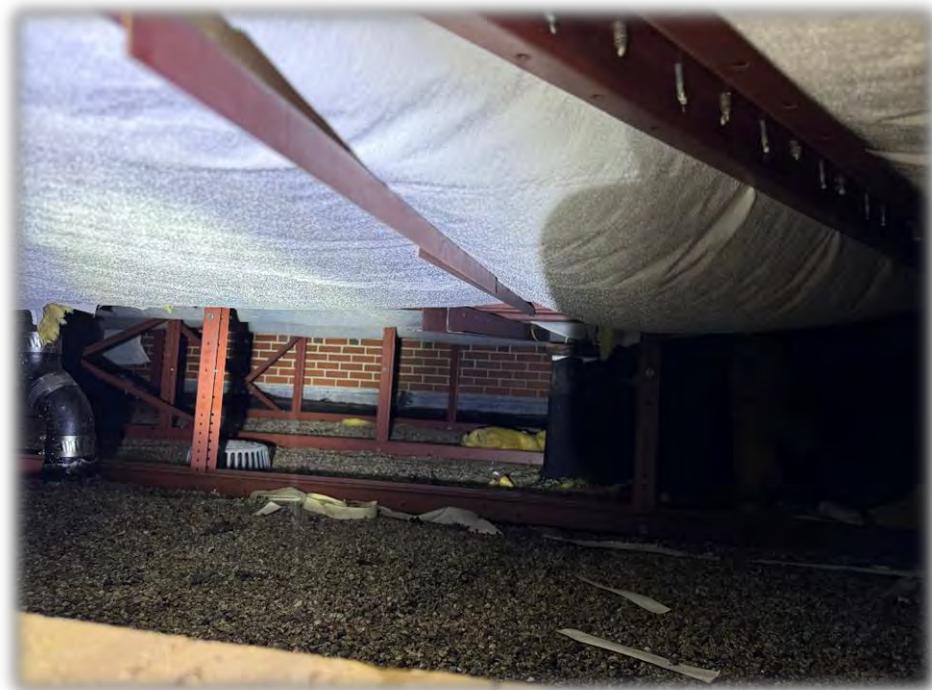
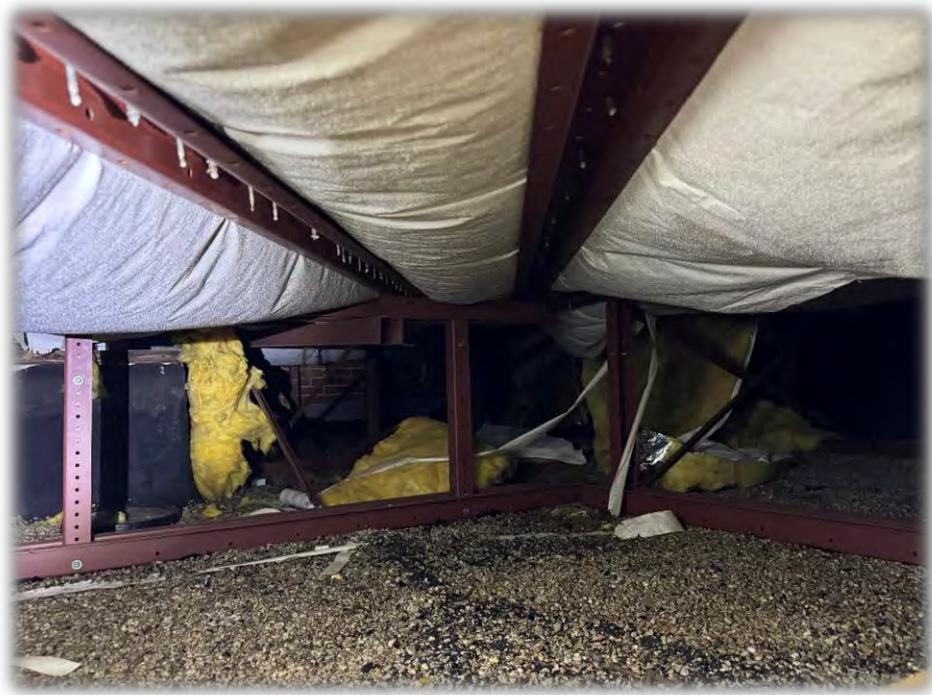
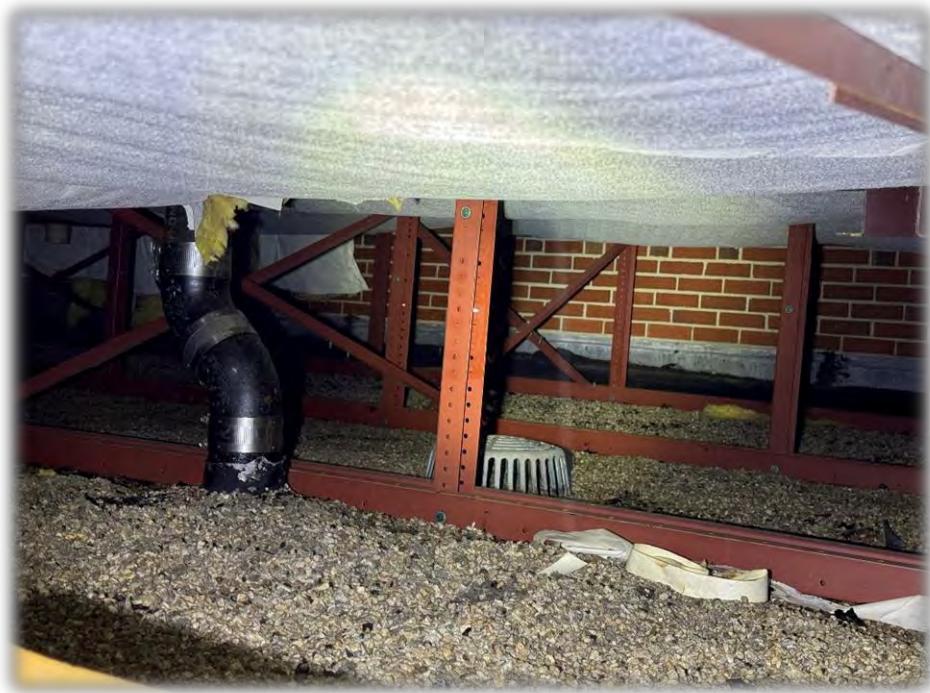
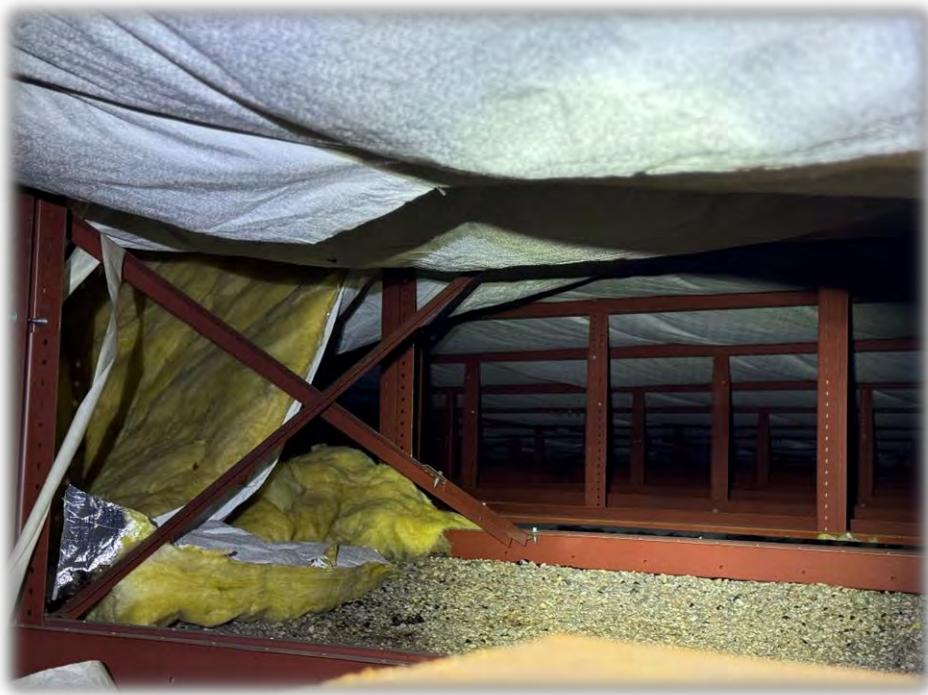
**Steel Support Structure** for the trapezoidal standing seam metal roof assembly is positioned atop the aggregate covered BUR membrane as shown in the series of photographs # 19 through 24. Due to tight dimensions of the accessway panel, actual inspection of the steel framework was unable to be performed in that enclosed space; however, it appears the steel framework and standing seam metal roof system may rely on dead weight to restrain the assembly atop the BUR assembly as there was no evidence of mechanical fasteners into or through the structural concrete roof panels. Such a scenario is unusual and comes with a degree of risk of uplift failure if exposed to severe wind loads such as associated with a microburst, derecho, or tornado. There is no remediation work to secure the steel structure in place at this time as such would be a costly venture, complicate eventual removal of the assembly to reroof the building and penetrations in the deck could easily compromise the panels. In addition, the loose laid metal roof assembly appears to have sufficient dead weight to restrain the framework and panels in place as evidenced by long term service. Note that such dead weight restraint of a metal roof assembly is neither common nor code compliant and may be supplementally secured to the structural concrete roof deck panels or to the top chords of the bar joists.

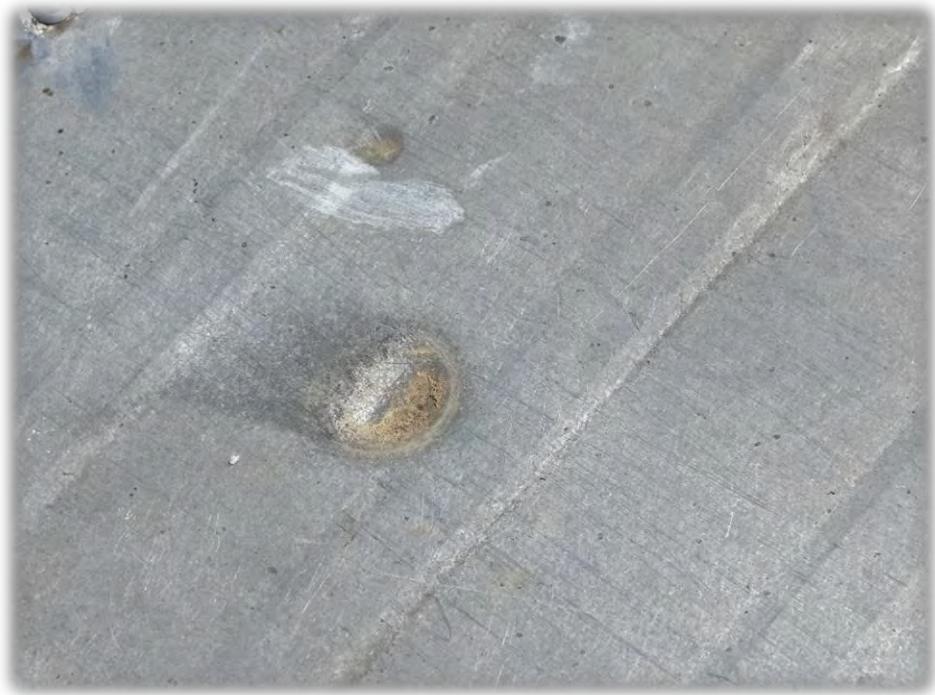
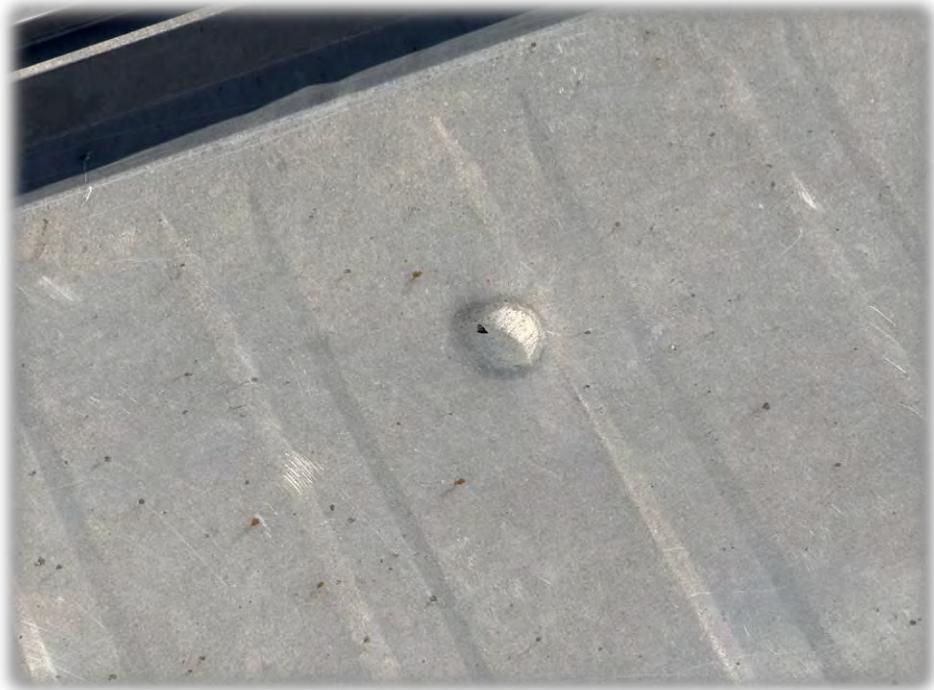
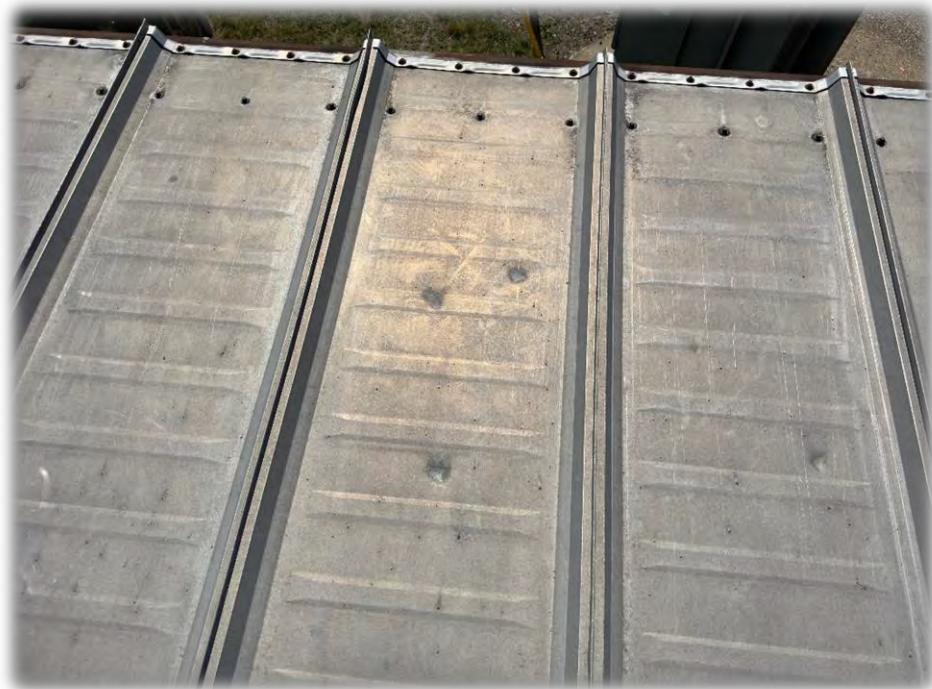
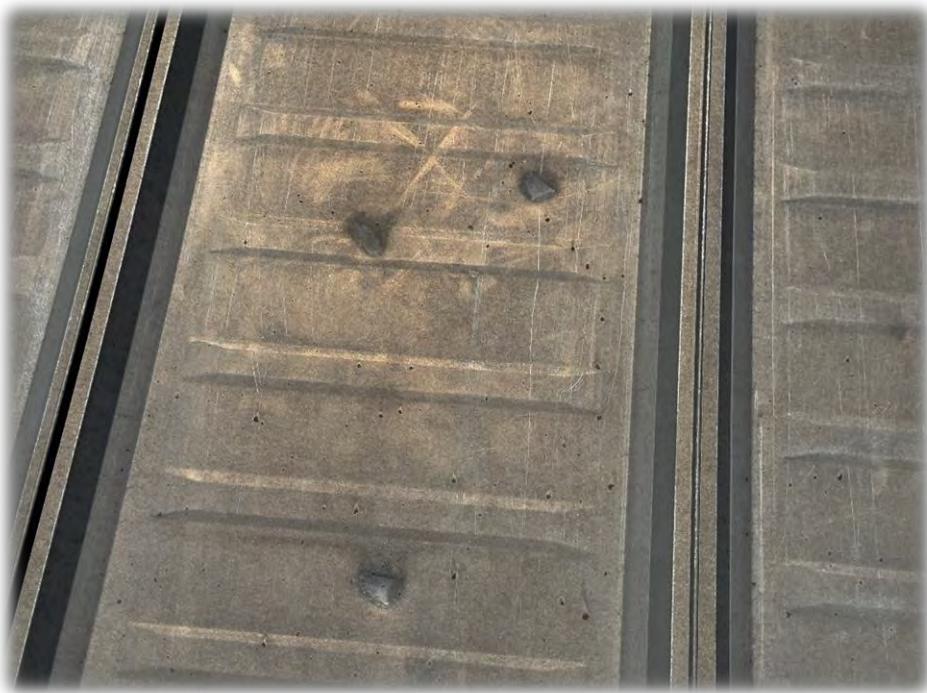
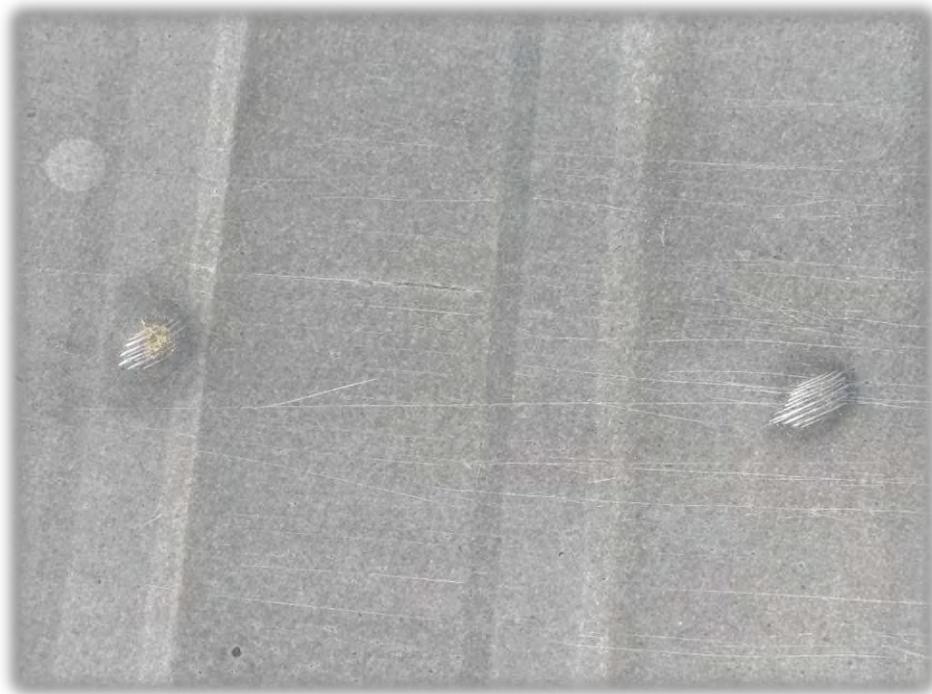
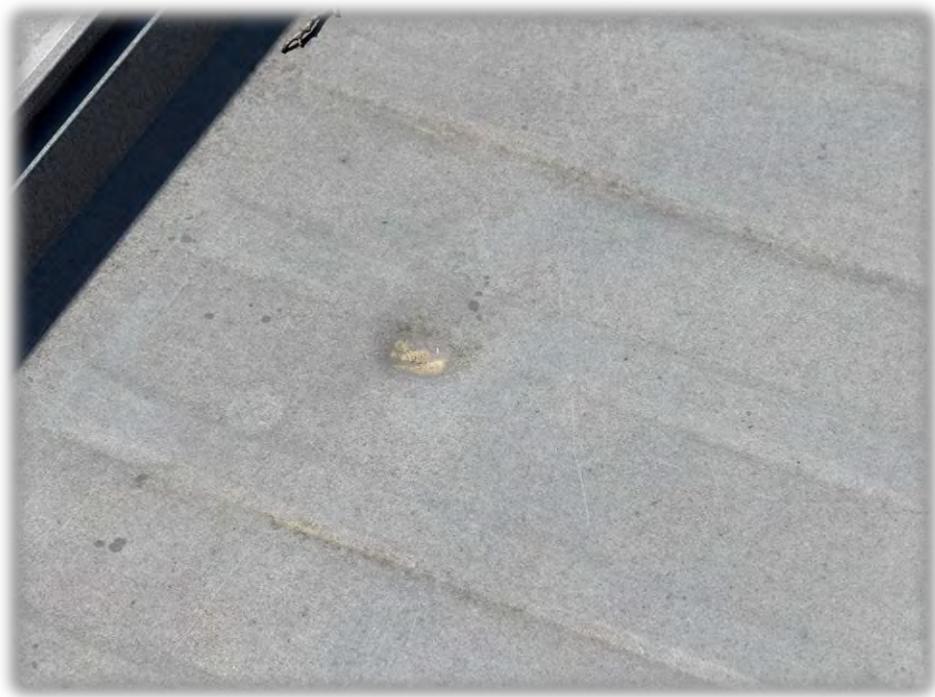
**Impact Damaged Panel Areas** were encountered about the metal roof assembly in no distinguishable pattern, with examples of the impact damaged area shown in the series of photographs # 33 through 41. At first glance the impact damaged areas could have been attributed to hail damage; however, with close observation of the dimple depressions, physical scrap marks can be seen such as in photographs # 37, 40 and 41. Hail impact dimples on a metal roof are circular not erratically shaped and do not have physical scrape marks, which indicates physical damage. These dimple depressions are not an imminent leakage threat but are commencing to experience surface rust as seen in photograph # 41, due to depressed surface areas holding water for a period of time after each precipitation event. The additional exposure to water while limited, takes a toll over an extended period of time. As it is the intent to maximize the length of effective service from this metal roof assembly, the impact damaged panel areas should be addressed with a skim coat of a solvent base flashing grade elastomeric which will bring the dimpled area flush with the metal panel surface and the solvent base elastomeric will neutralize the early stage oxidation process. Solvent base elastomeric materials specified for Northridge projects include; Truco Super Seam Seal, Topps RivetGard, Karnak Karna-Flex 502 Seam Sealer and GAF TopCoat SB-900. This work should be initiated within the next 12 months, coordinated with other metal roof restorative work items as outlined within this report. The cost for performance of the solvent base flashing grade elastomeric material within impact damage panel areas is estimated at **\$535.00**, reflecting five (5) man hours of labor at \$85.00 per hour along with a material allotment of \$110.00.

1.	<b>Apply Solvent Base Sealant In Impact Damage Dimples</b>	<b>Field Locate Impact Metal Panel Surface Dimples, Clean &amp; Fill Areas with Solvent Base Elastomeric</b>	<b>\$535.00</b>	<b>Within 12 Months</b>

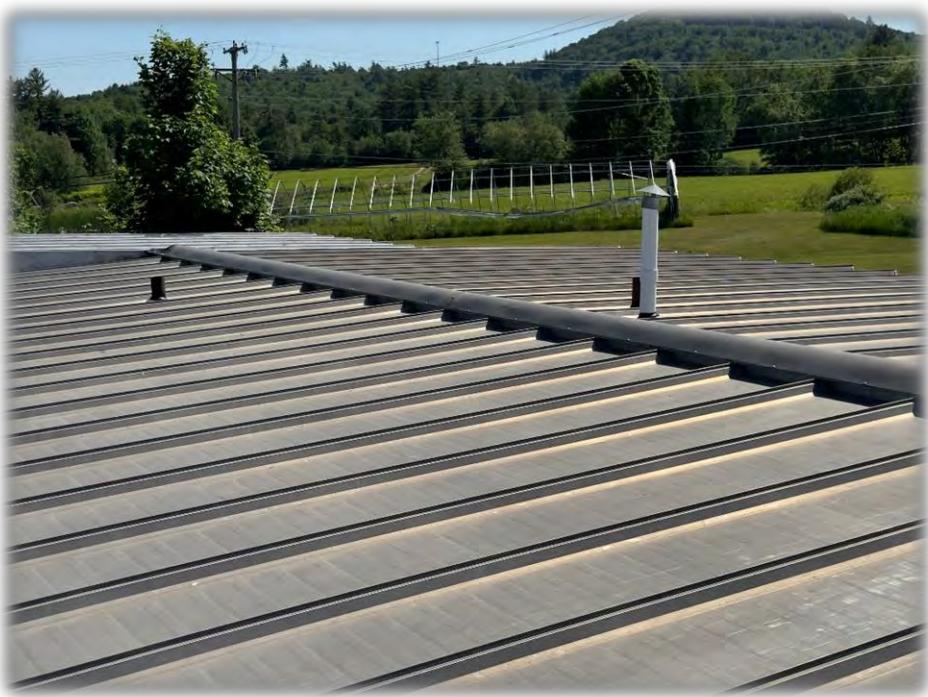
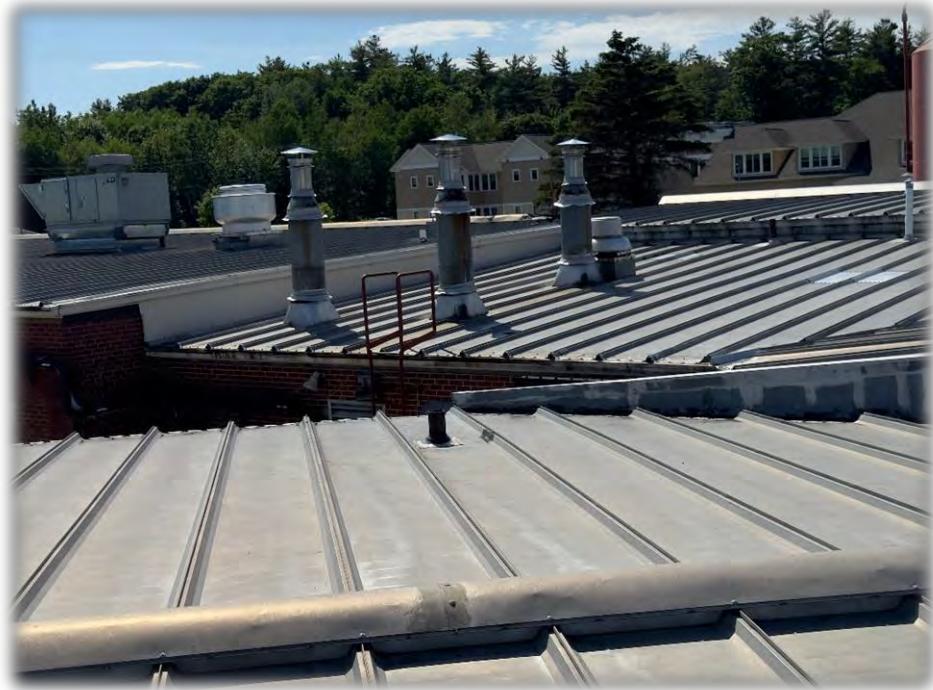
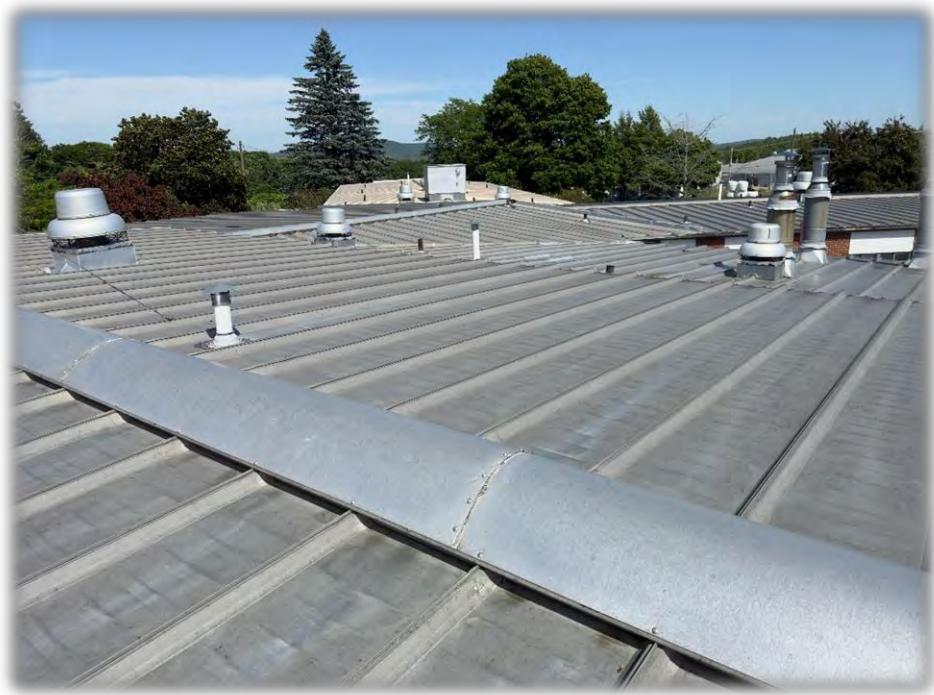
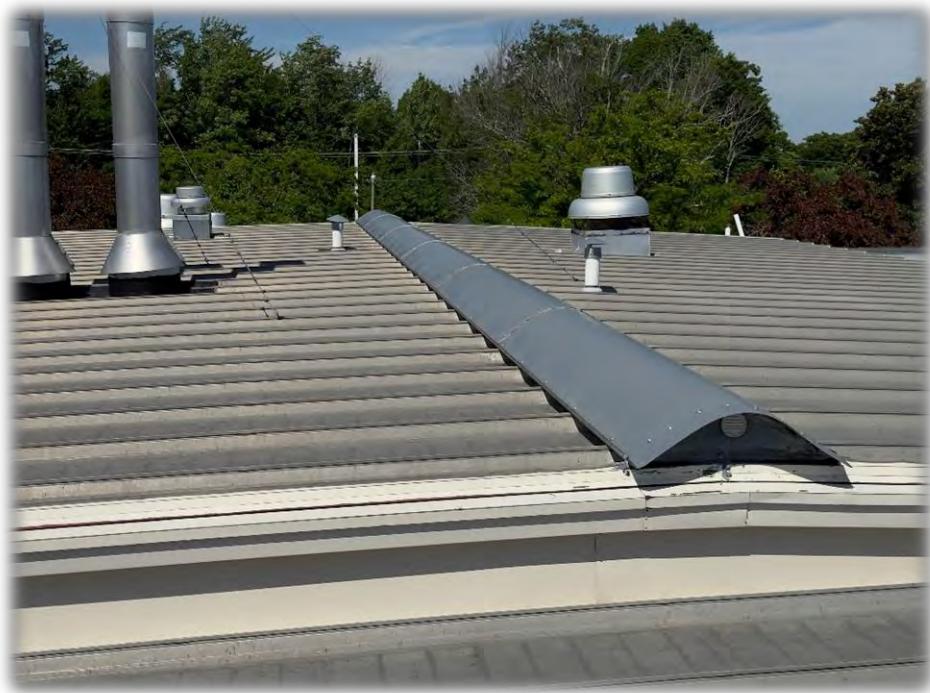
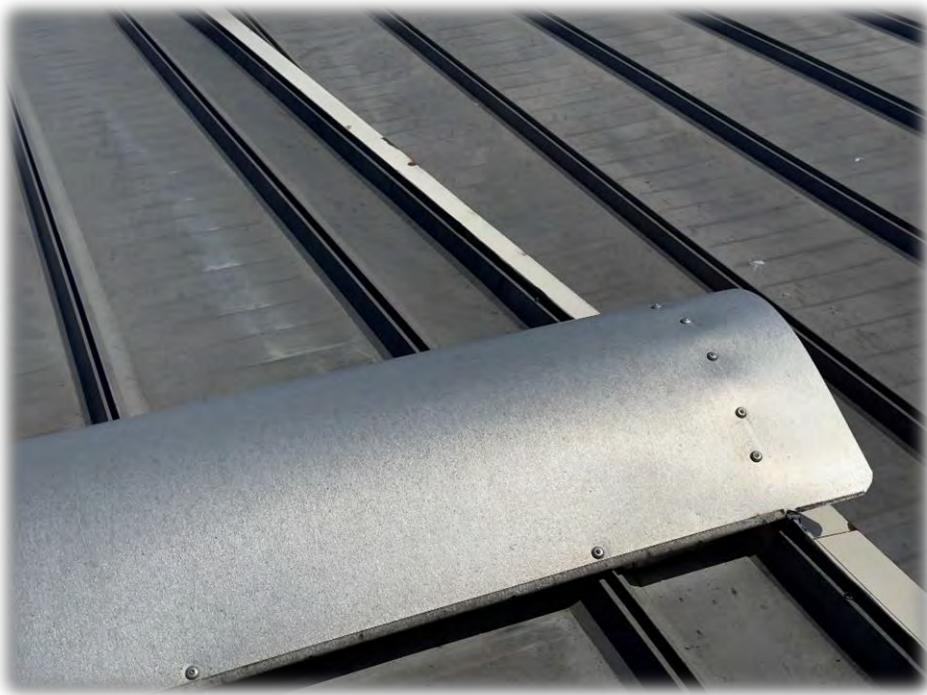
**Ridgeplate Assemblies** on the Butler standing seam roof areas consist of an elevated bowed metal panel as shown in photographs # 42 through 47 with pop rivets along the lower edges of the bowed plate profile and within each transverse overlap seam. Beneath the ridgeplate assembly is a formed metal closure strip that remains tightly secured with sealant along edges of the baffle plates. As the sealant continues to age, dry out, crack and erode, a point of entry may be created for wind driven precipitation to enter the building. At that time, a dry tool bead of sealant should be applied along interface edges of the metal baffle and the metal panel surface; however, no such work is required at this time or anticipated to any degree over the next ~ 5 years. Despite the age of the sealant beneath this ridgeplate the sealant and metal baffles are protected by the ridgeplate overhang which moderates deterioration of these components.

Butt edges of the bowed ridgeplate assemblies are typically fitted with a rubber bellows style ridge cap which is absent on these roofs, rather the butt ends of the ridgeplates were overextended to offer protection to the recessed formed closure panels, as seen in photograph # 46. There is no dedicated restorative work effort for the ridgeplates, with any future leaks to be addressed at the direction of management with the cost deducted from phased leak repair allotments as outlined in a separate paragraph later within this report.

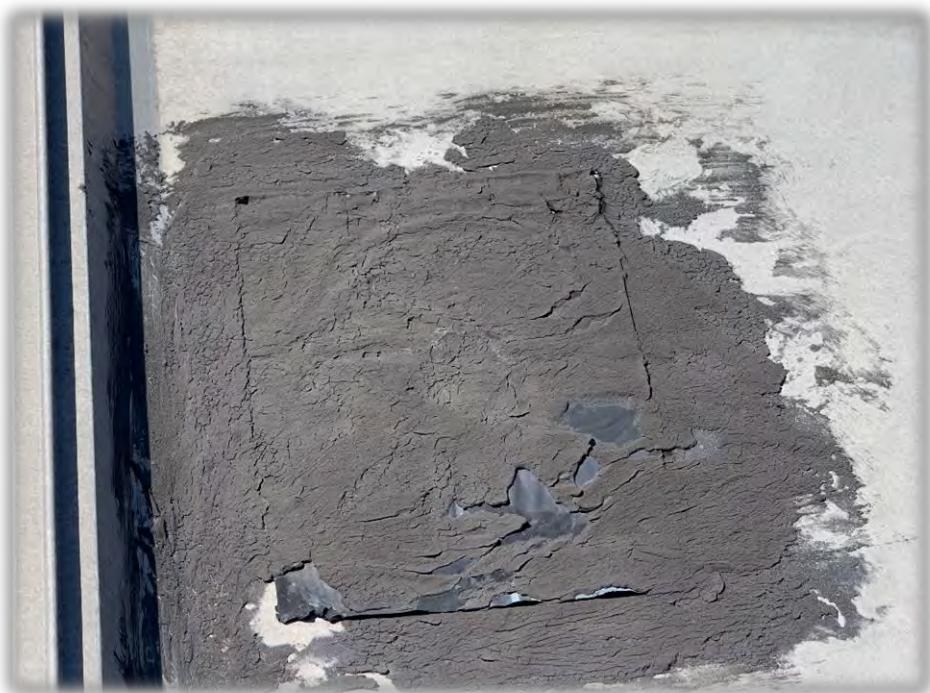
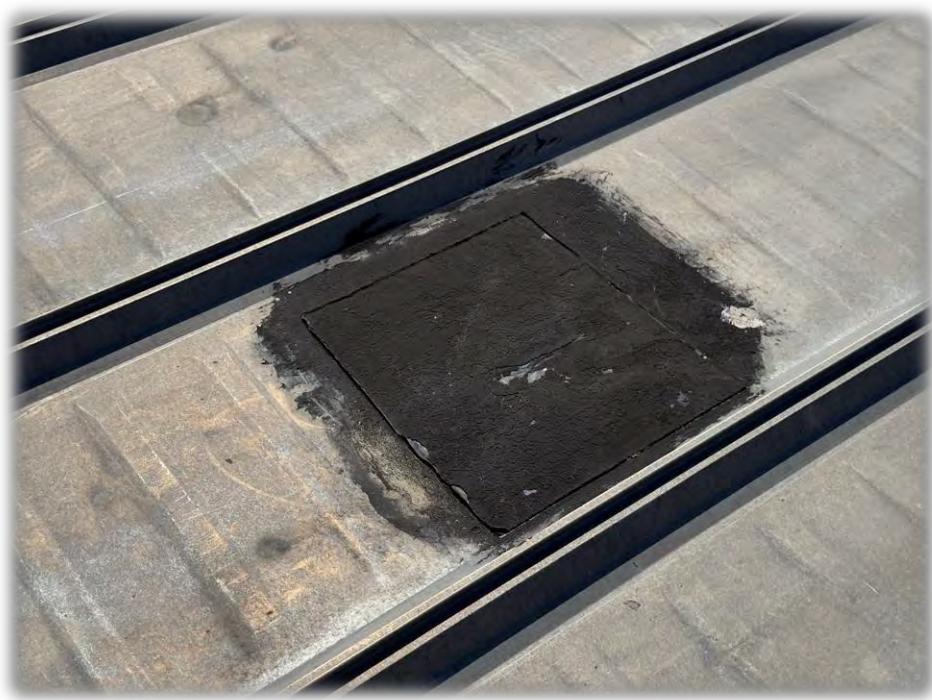
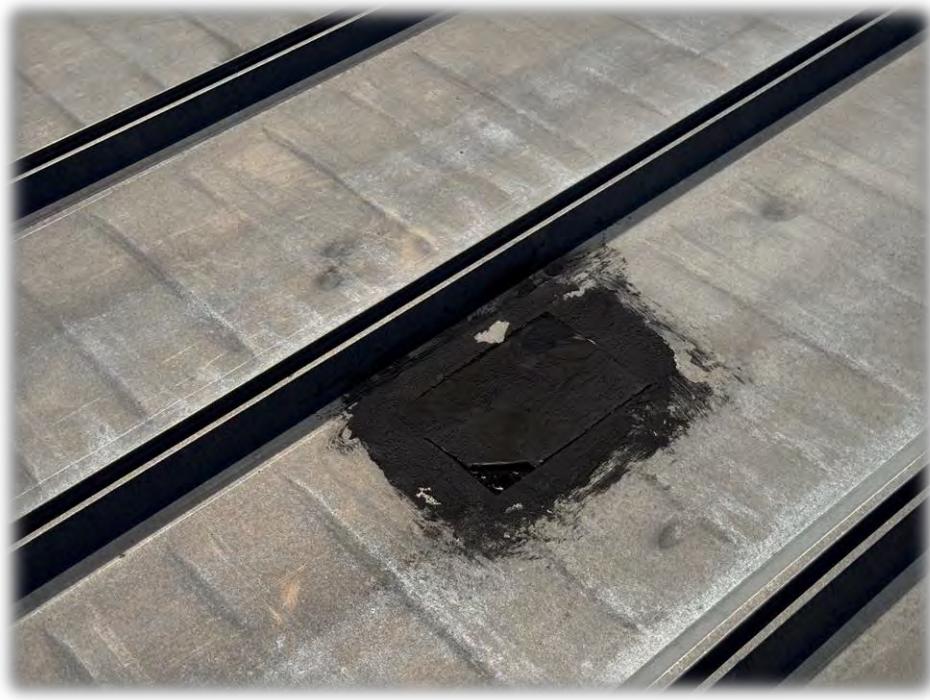
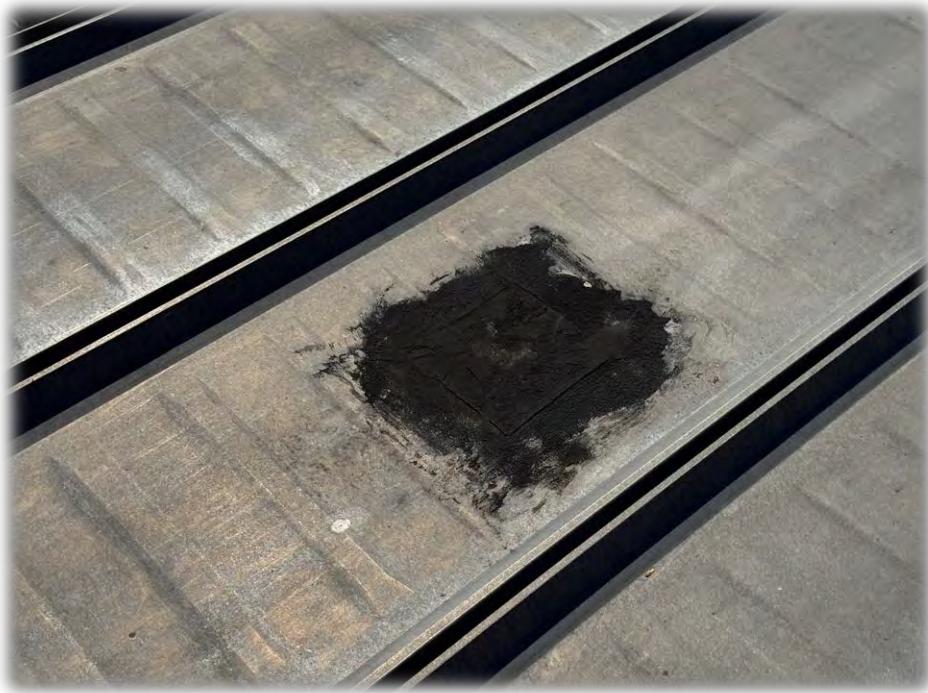
**Asphalt Flashing Patches** were encountered atop the Butler standing seam metal roof panels in a limited number of areas, identified on the scale Roof Plan Drawing A – 1 and seen in photographs # 64, 65, 66 and 67. Same as with the asphalt flashing cement employed at the exhaust fan curb units, the cost effective option to remediate these substandard patch areas is to properly clean the areas, removing loose asphalt cement with a pressure wash followed by cleaning, priming and covering the areas with new high grade foil face peel and stick flashing membrane, installed to exceed the parameters of the asphalt patches at least 2" all around. This recommended asphalt patch covering work should be initiated within the next 12 months, coordinated with the other peel and stick flashing work on these Butler metal standing seam metal roof areas. The cost for recommended foil face membrane covering the asphalt flashing patches is estimated at **\$455.00**, reflecting four (4) man hours of labor at \$85.00 per hour with a material cost of \$115.00.

4.	<b>Flash Over Asphalt Patches With Foil Face Peel and Stick</b>	<b>Surface Clean the Asphalt Flashing Patches, Prepare and Cover With Foil Face Peel and Stick Membrane</b>	<b>\$455.00</b>	<b>Within 12 Months</b>

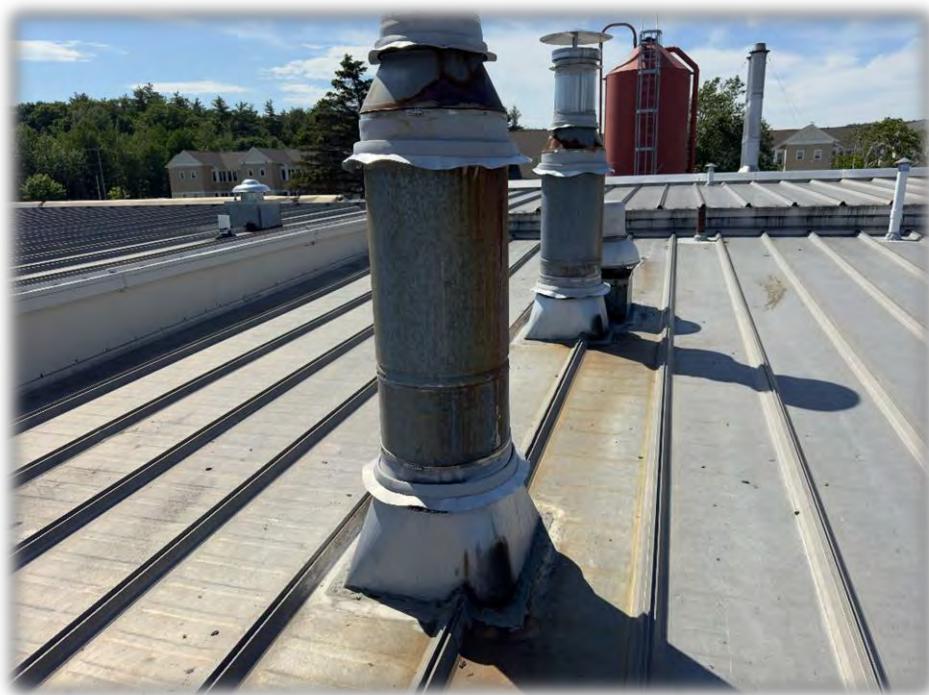
Photograph # 68 ⚡

**Gas Flue Stacks** were located about the central metal roof areas and both angular wing areas as seen in photograph # 68 and noted on the scale Roof Plan. The gas flue stacks were flashed with raised metal flanges with the flat steel plates set in sealant and screw fastened to the metal panels and protected with storm collars. The watertight integrity of these gas flue stack flanges relies on the aging embrittle sealant along the perimeters of the flanges, similar to the exhaust fan curbs but without asphalt flashing, which is not a long term flashing assembly and should be replaced within the next 12 months.

The recommended pro-active restoration work is to utilize a high grade foil face peel and stick flashing membrane along the flange surfaces after cleaning and priming the areas. The new foil face flashing should extend up the angular flange surface 2" and out past the edges of the flanges onto the metal panels also by 2". Gas flue stack flashing work with foil face peel and stick membrane has an estimated cost of **\$865.00**, reflecting eight (8) man hours of labor at \$85.00 per hour along with a material cost of \$185.00.

5.	<b>Re-Flash Gas Flue Stacks With Foil Face Peel and Stick</b>	<b>Prep Gas Flue Stacks to Remove Sealants, Re-Flash With Foil Face Peel and Stick Flashing Membrane</b>	<b>\$865.00</b>	<b>Within 12 Months</b>

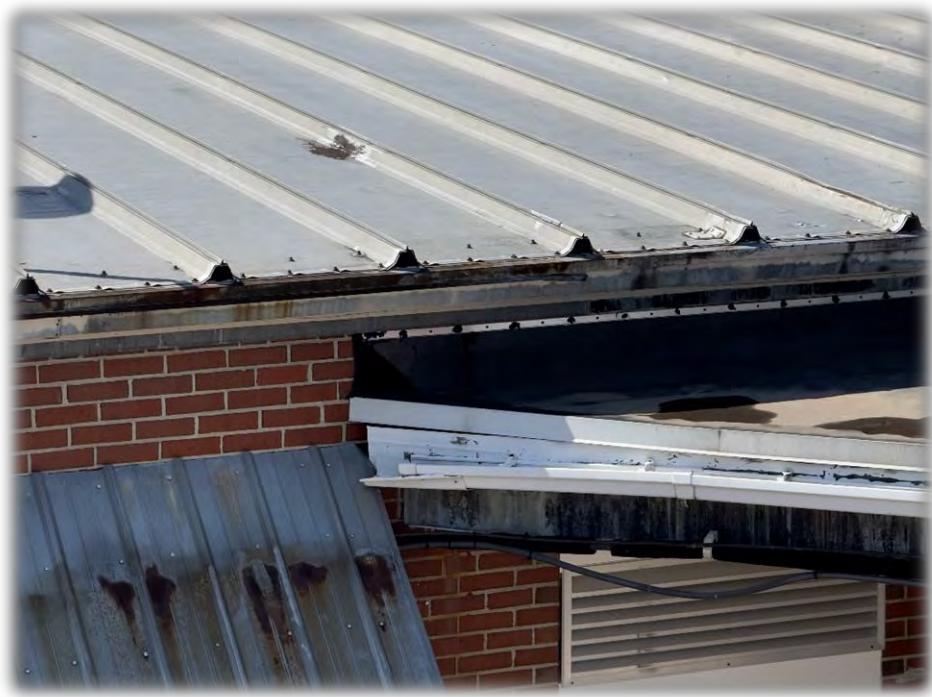
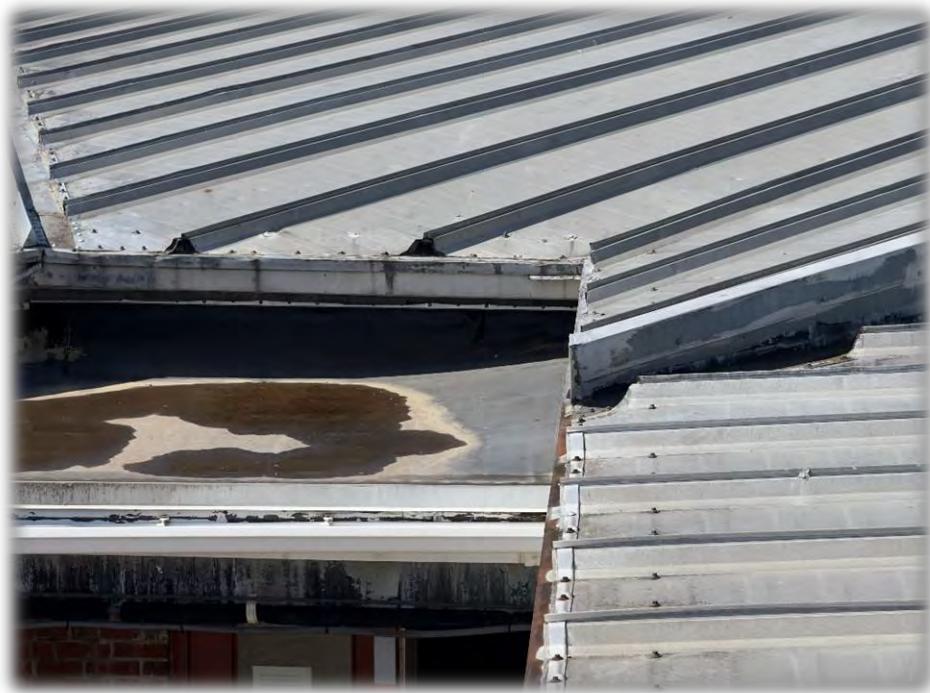
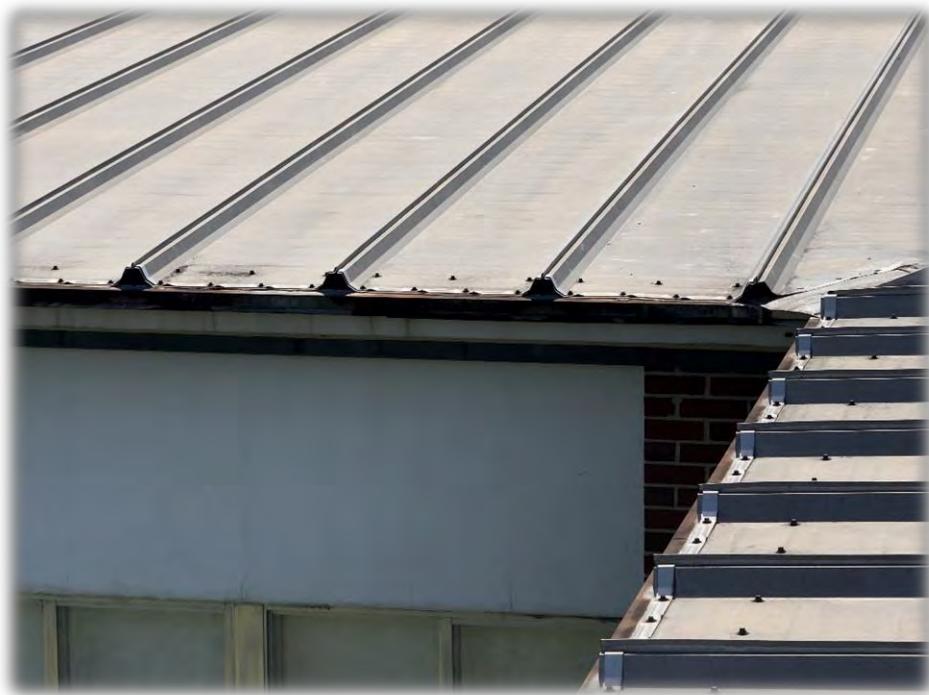
**Lower Panels** were encountered with a formed Butler batten along the edges as seen in the series of photographs # 69 through 74 without any instances of rusting or failed battens noted. The lower sections of the metal panels have screw fasteners through the panels as seen in photographs # 73 and 74, a percentage of which have been replaced including some with what appear to be proper stainless steel fasteners with an integral washer and flange while others were replaced with a standard screw fasteners and standard flat washers which is not an acceptable assembly as the interface between the flange on the screw fastener and the flat washer is not watertight. Such fasteners may properly function in light precipitation but in periods of heavy precipitation and exposure to snow and ice, the fasteners will leak water into plenum between the metal roof and underlying BUR assembly. In order to proactively address the substandard replacement fasteners, such should be field located, removed and replaced with oversized stainless steel EPDM washer fasteners, a diagram of which is provided to the right of this text for reference.

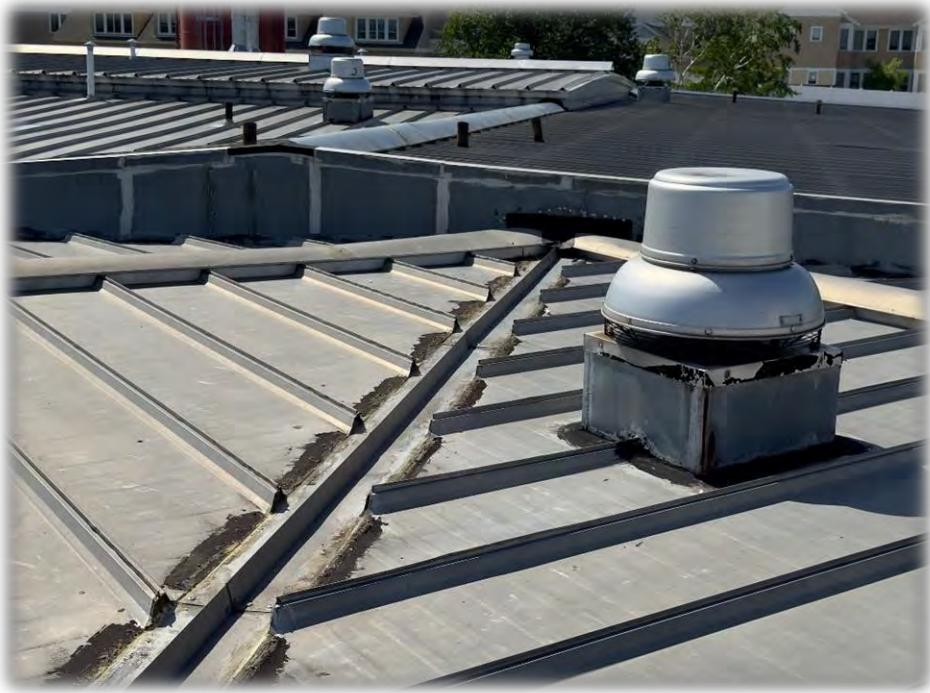
Photograph # 75 ⚡

**Valley Gutter** was encountered between separate metal roof areas in the East central section of the building as seen in photographs # 75 and 76 and noted on the scale Roof Plan. Such valley gutter channels are not optimal on a metal roof assembly but necessary in select construction environments. The lower metal panels are not fitted with formed batten as the lower panel edges are, due to the elongated angular cut of the channels between the raised standing seams. The recessed gutter channel should be sufficient to accommodate sheet drainage without issue as the size of the metal panels above the valley gutter is limited. If the metal panel areas were larger, the flow of sheet drainage could in a heavy precipitation event, impact against the opposite drainage flow and splash back on the lower panel edges. The lower panel edges against the valley gutter has already been addressed with asphalt flashing cement, indicating a prior issue along this area. The recommendation is for the lower panel edges on both sides of the valley gutter to be proactively flashed with foil face peel and stick membrane, ~ 1/2" from edge of the gutter to 2" past the edge of asphalt.

In addition, the lower foam closure strips within the angular cut trapezoidal standing seam profiles should be rejuvenated with a generous tolled bead of a flashing grade solvent base material as outlined earlier in this report for addressing impact damaged panel areas. This sealant work should also be initiated within the next 12 months, coordinated with other metal roof restorative work items as outlined within this report. The cost for installation of the foil face high grade peel and stick flashing membrane along the lower panel edges on both sides of the valley gutter as well as elastomeric re-sealing the adjacent closure strips with a solvent base flashing grade material is estimated at **\$1,565.00**, reflecting fourteen (14) man hours of labor at \$85.00 per hour along with a material allotment (foil face peel and stick membrane and elastomeric) of \$375.00.

8.	<b>Re-Flash Panels Along Valley Gutter with Foil Face Peel &amp; Stick</b>	<b>Prep Panel Ends Along Valley Gutter &amp; Flash With Foil Face Peel &amp; Stick Membrane, Sealant at Closure Strips</b>	<b>\$1,565.00</b>	<b>Within 12 Months</b>

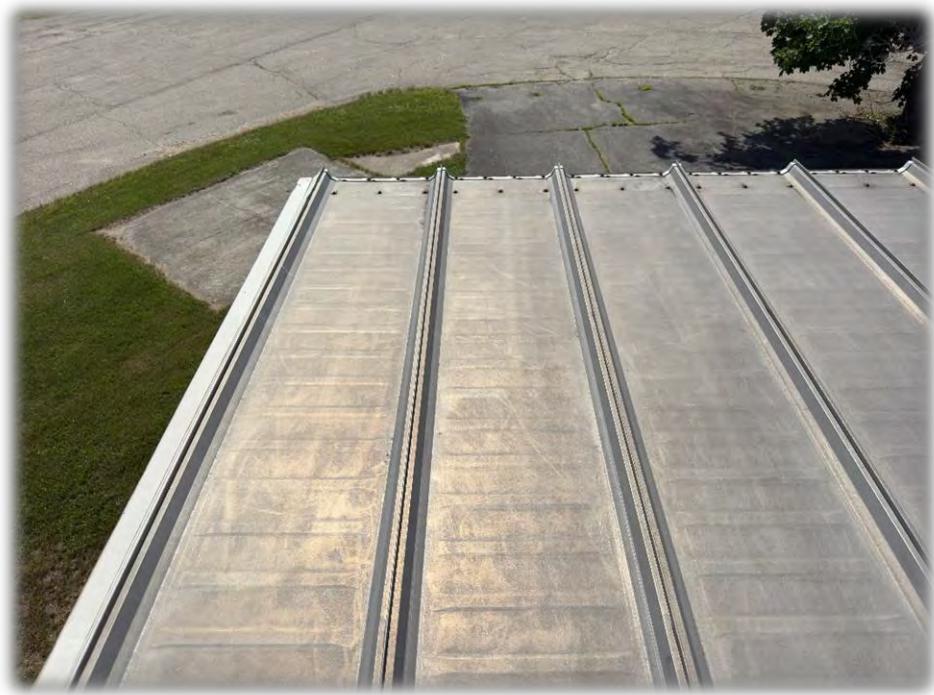
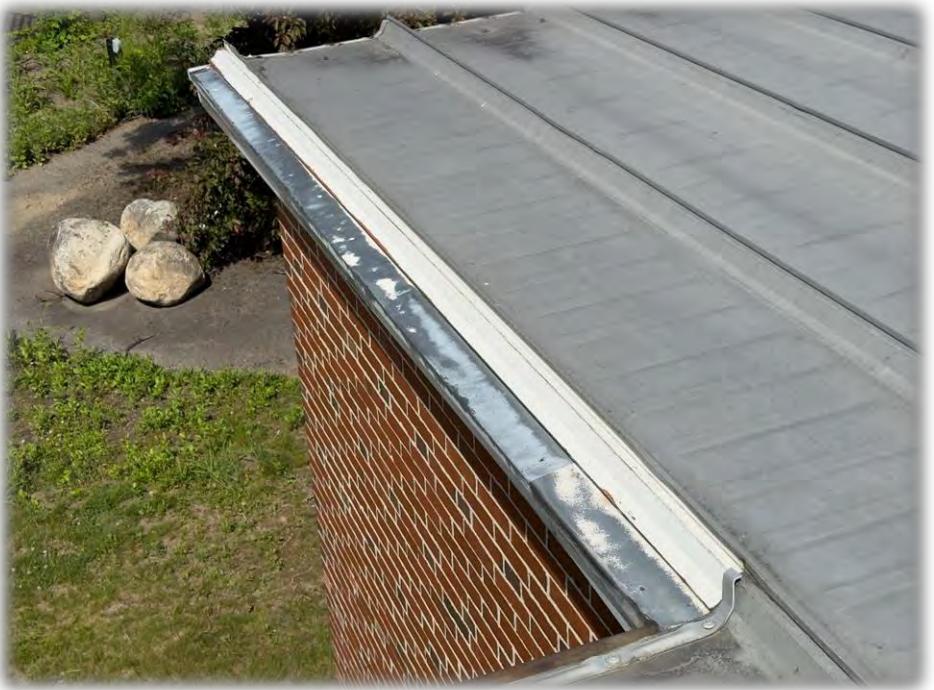
**Rake Edge Flashings** were positioned along the sloping non-drip edge elevations of the Annex building as shown in photographs # 77, 78 and 79. Connection between the standing seam metal panels and sloping edge rake flashing panels was accomplished with a series of screw fasteners through the horizontal flange of the flashings after being set in a generous bead of sealant with metal counter-flashings. There is no issue with the rake edge metal assemblies on any of the roof areas.

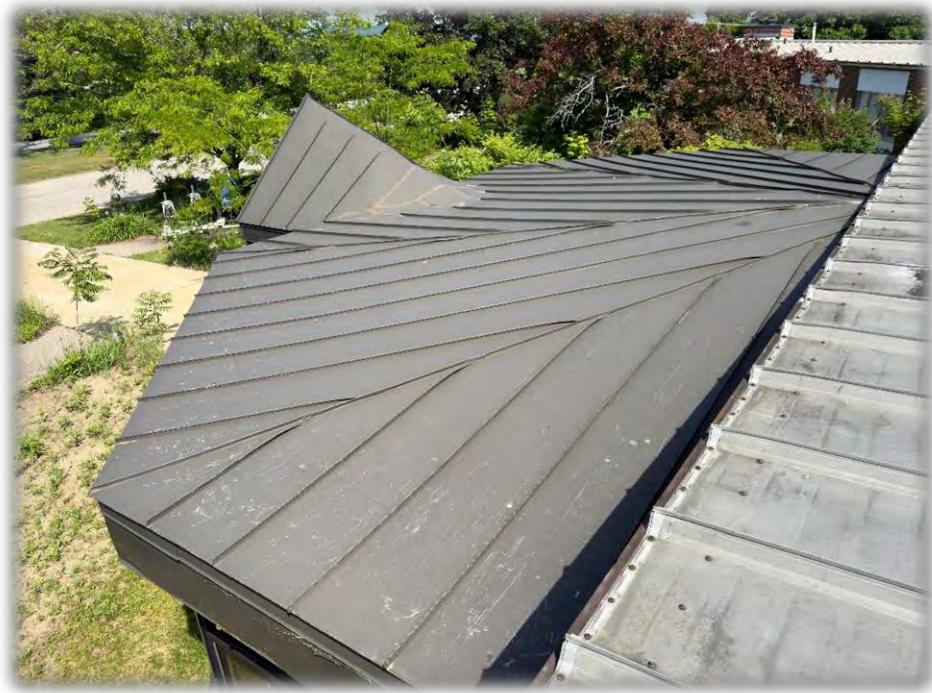
Photograph # 81 ⚡

**Overviews** of the unidentified standing seam metal roof assembly atop the front entranceway as shown in photographs # 80 and 81 and noted on the scale Roof Plan. This metal roof area measures off at ~ 822 sq ft and includes a raised dormer over the front doorway to shed snow and ice away from the passageway. The metal roof is a vertical leg style assembly as diagrammed to the right in contrast to the trapezoidal standing seam assembly on the main building. The vertical leg standing seam metal panel securement was free of exposed fasteners with the lower panel edge folded over onto the underlying panel. There is no direct access to the entranceway roof surface.
