# Roof Condition Report

Documentation, Analysis and Recommendations for  
the Standing Seam Metal and EPDM Roof Assemblies

Carroll County  
Annex Building  
10 County Farm Rd  
Ossipee, NH 03864

June 26, 2024

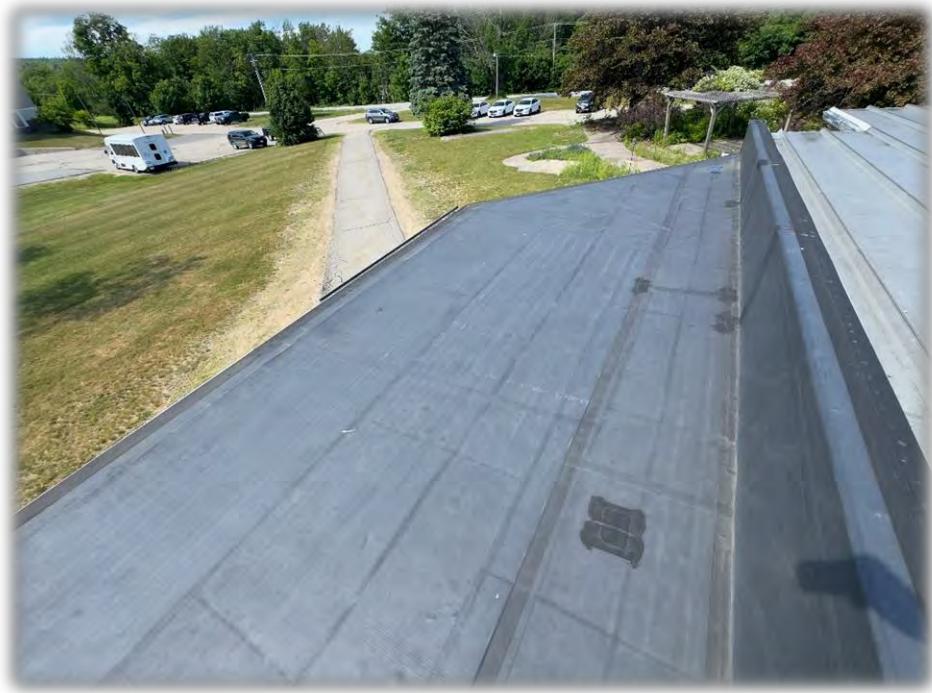
Photograph # 85 ⚡

**Overviews** of the adhered EPDM roof system atop the designated areas of the Annex building are shown in photographs # 85, 86, 87 and 88 for that larger section of roof along the West elevation of the building, shown on the scale Roof Plan. This roof area measures ~ 494 sq ft and appears to have been installed as part of the Annex building modification that saw demolition of the West elevation angular wing areas. The manufacturer of the EPDM roof system is unknown. The adhered EPDM roof membrane appears to be 60 mil installed atop a stratum of assumed polyisocyanurate insulation, without any penetrations and with butyl tape used in the seams. The EPDM roof membrane was extended up the vertical wall leading to the metal roof assembly as seen in photographs # 87 and 92. There were two other small fully adhered EPDM roof areas noted during the inspection, as seen in photographs # 89, 90 and 91 with the areas noted on the Key Plan and scale Roof Plan on Drawing A – 1. Drainage is allowed to free fall off the lower EPDM roof edges except for the East elevation area noted in photograph # 91 which is fitted with a gutter channel. For general reference, a diagram of a fully adhered EPDM roof assembly is provided to the right of this text for general reference showing a mechanically secured polyisocyanurate roof insulation layer atop a corrugated steel deck with the EPDM membrane adhered to the insulation facer with a vapor barrier. The deck on the larger EPDM roof area rests atop newer composite deck panels shown in photographs # 93, 94, 95 and 96. The adhered EPDM roof systems may be covered under Warranty which is typically issued for 10 or 15 years; however, without penetrations, use of butyl seam tape and a quality installation, no leaks are anticipated on these EPDM roof assemblies for the next ~ 5 years.
