# Roof Condition Report

Documentation, Analysis and Recommendations for  
the Standing Seam Metal and EPDM Roof Assemblies

Carroll County  
Annex Building  
10 County Farm Rd  
Ossipee, NH 03864

June 26, 2024

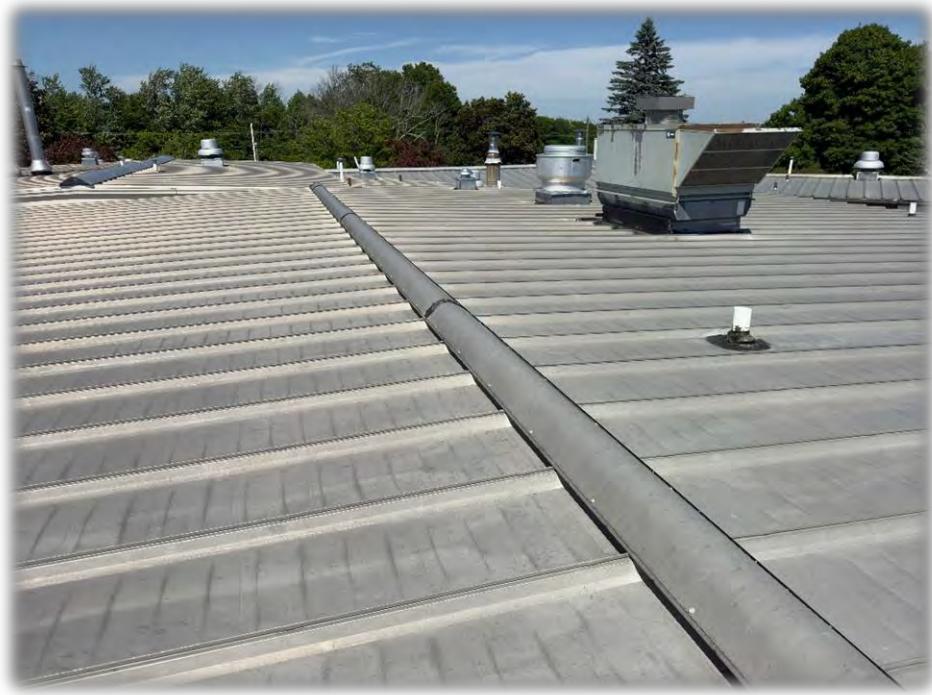
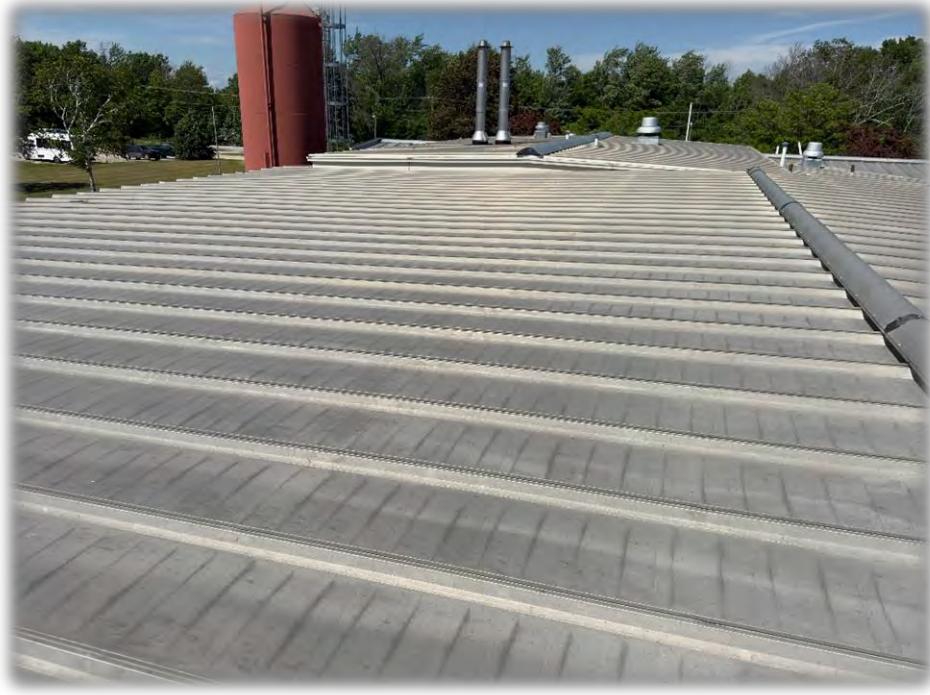
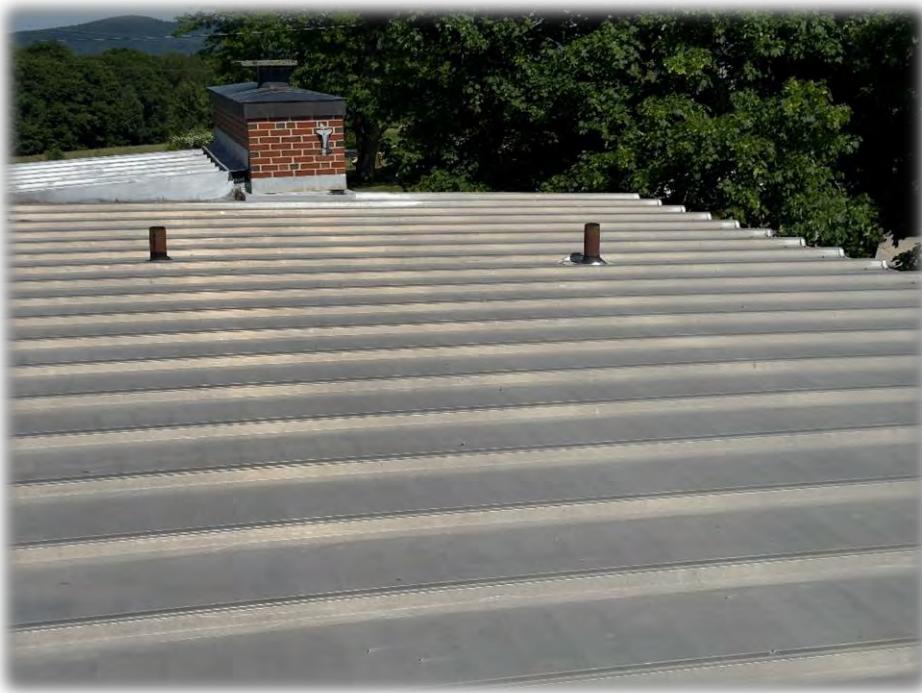
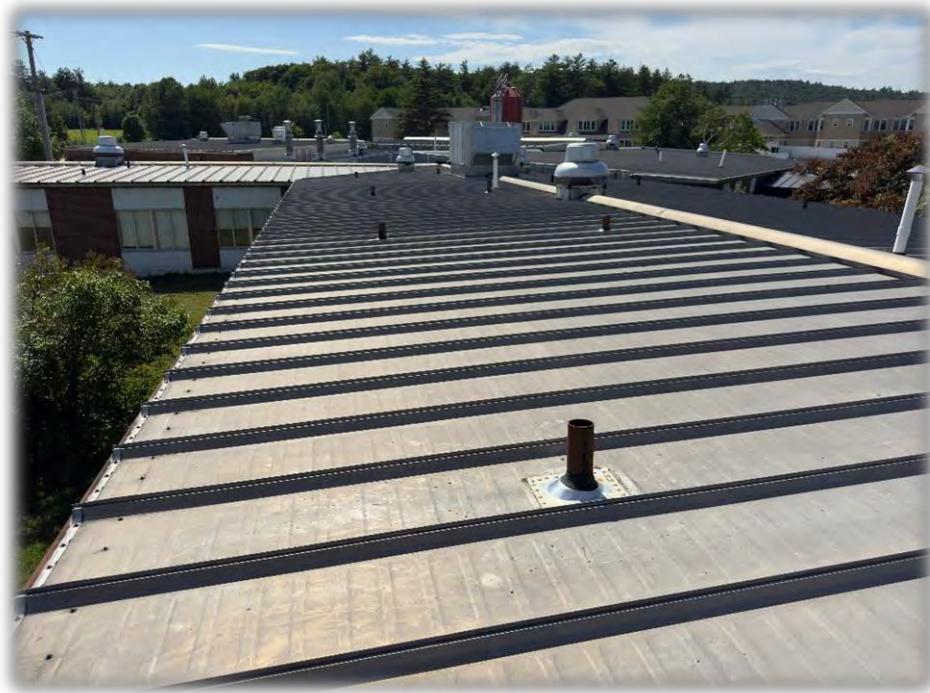
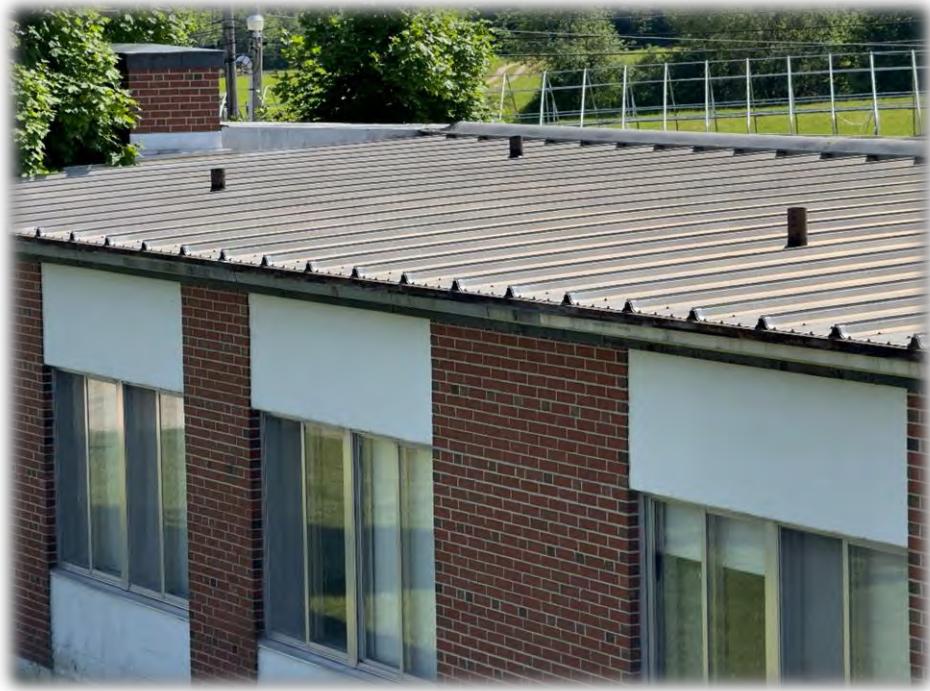
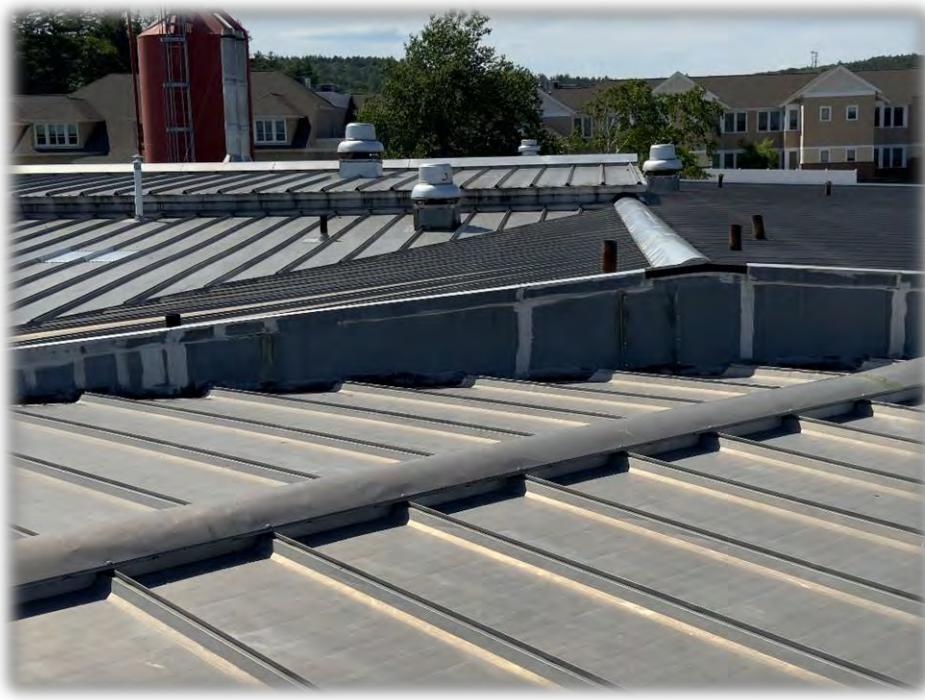
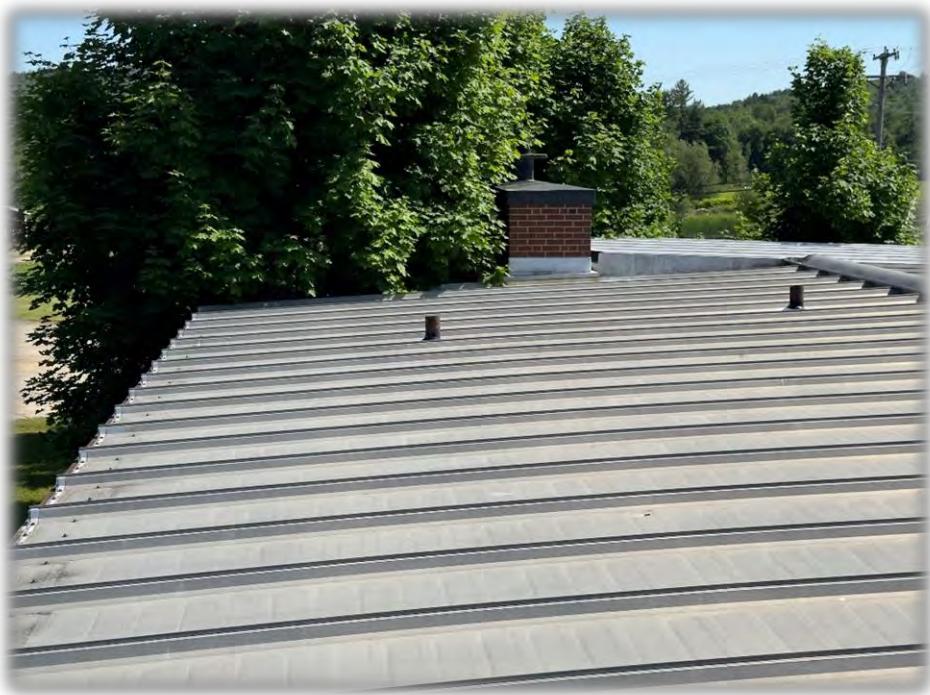
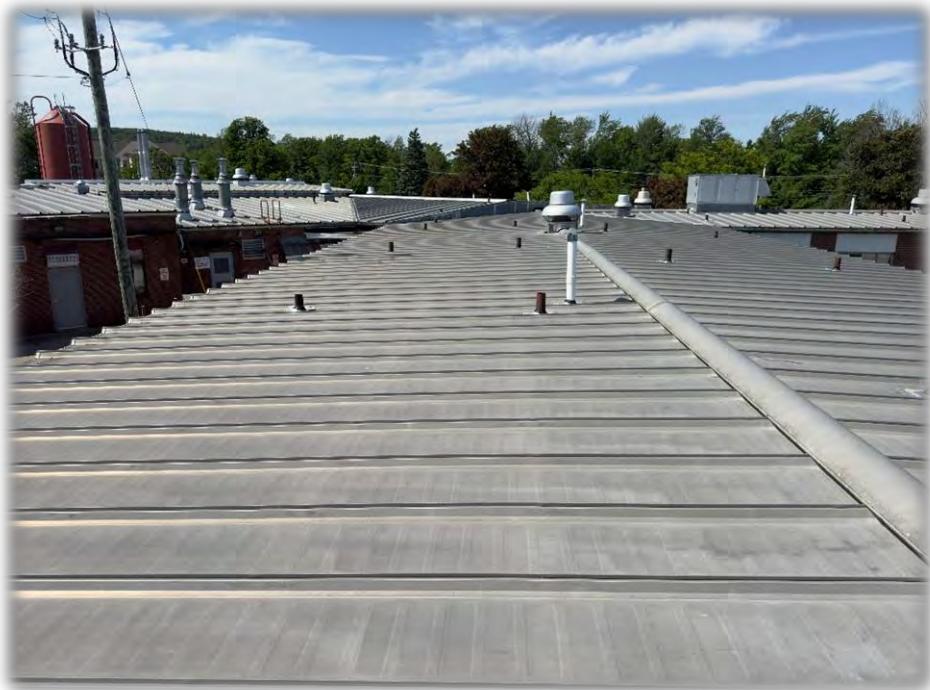
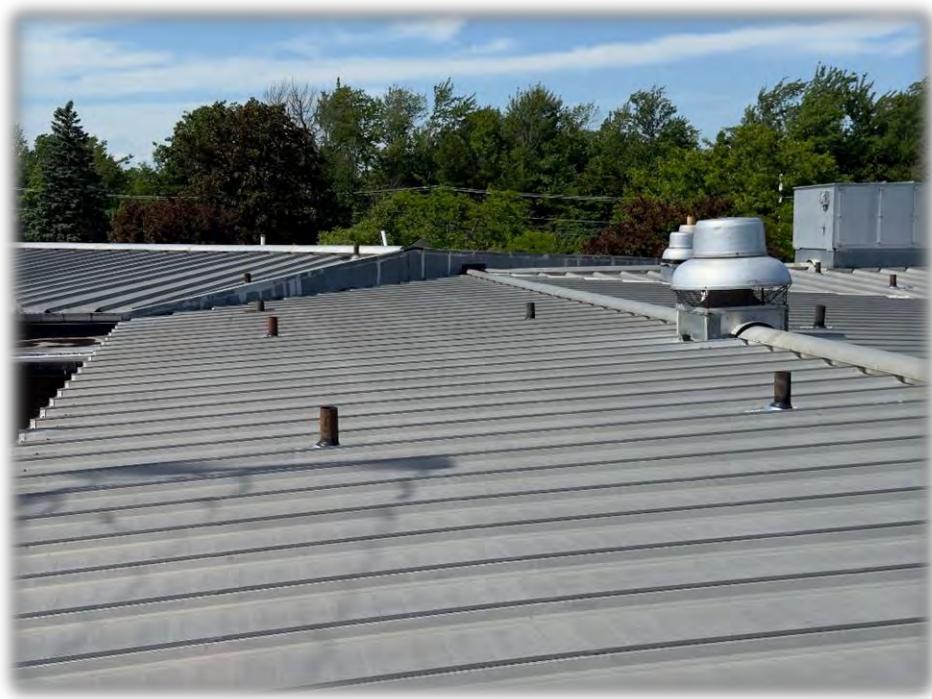
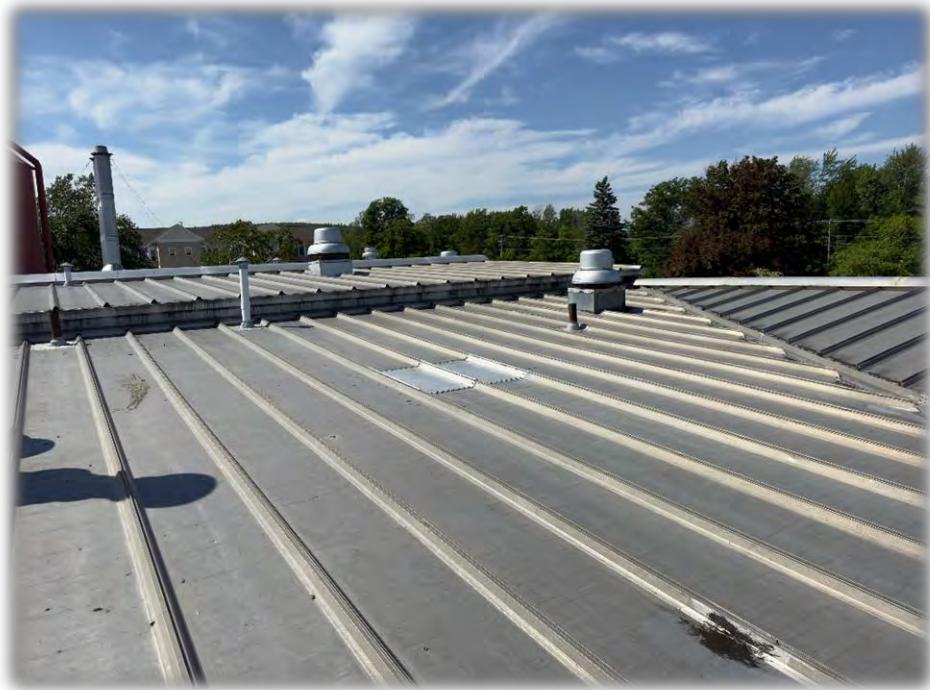
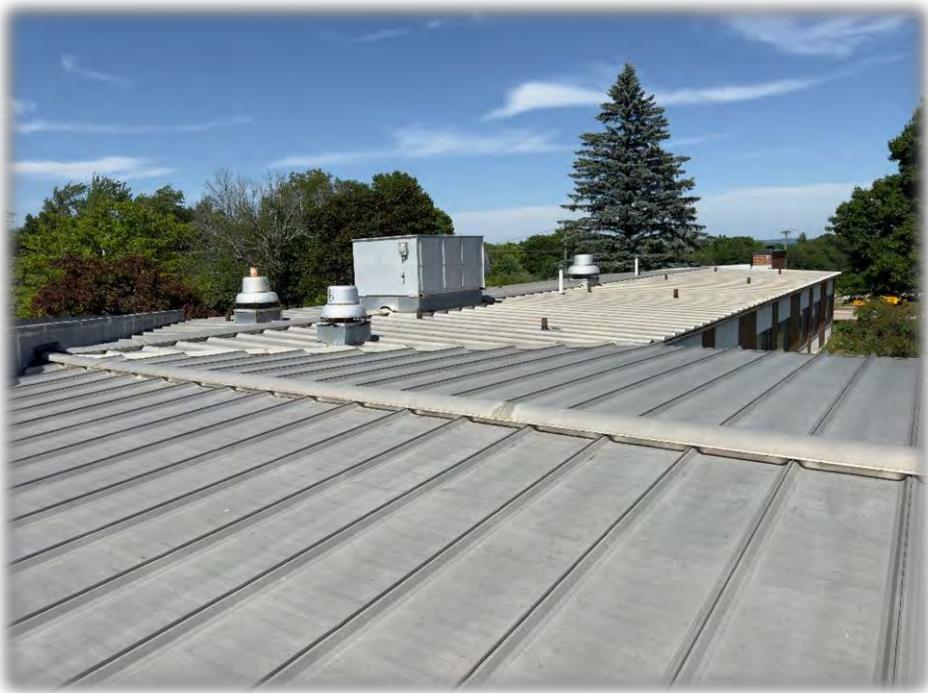
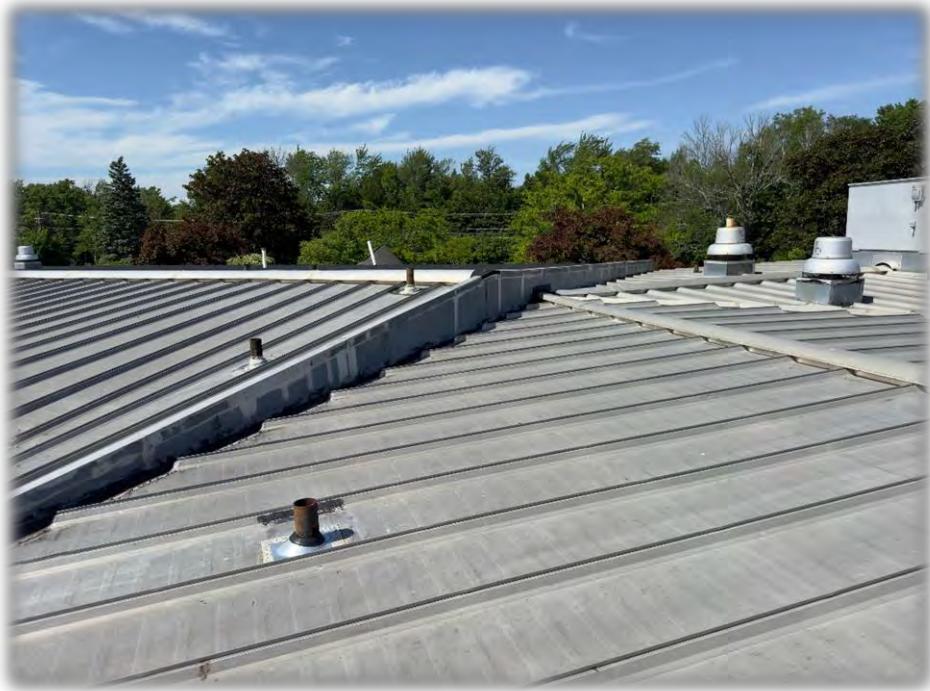
**General Overviews** of the Butler trapezoidal standing seam metal roof systems atop the various areas that comprise the Annex Building are provided in the series of photographs # 1 through 12 with the areas shown on the scale Roof Plan and Key Plan on Drawing A - 1. Access to the metal roof surface was accomplished via the fixed exterior ladder positioned along the East elevation of the main portion of the Annex building as shown in photograph # 13 and identified on the scale Roof Plan. The access ladder is not fitted with a safety cage or personal fall arrest system which is adequate at present but must be upgraded by November 18, 2036 to comply with OSHA 29 CFR 1910.28(b)(9), without any modification work required at this time due to the overall low height of the fixed ladder. An inquiry with management personnel indicated this Annex building is effectively watertight at the time of the Northridge inspection with previous leakage having been addressed. The metal panels have a 24" wide profile with the trapezoidal standing seams rising up 3". The Butler trapezoidal standing seam metal roof system is secured to the underlying steel support substructure with a series of vertical steel tabs integrally folded and double locked within the vertical portions of the standing seams with sealant within the fold profile as diagramed to the right. Drainage on the Butler trapezoidal standing seam metal roof areas is allowed to free fall off lower edges of the areas as identified on the scale Roof Plan on Drawing A - 1.

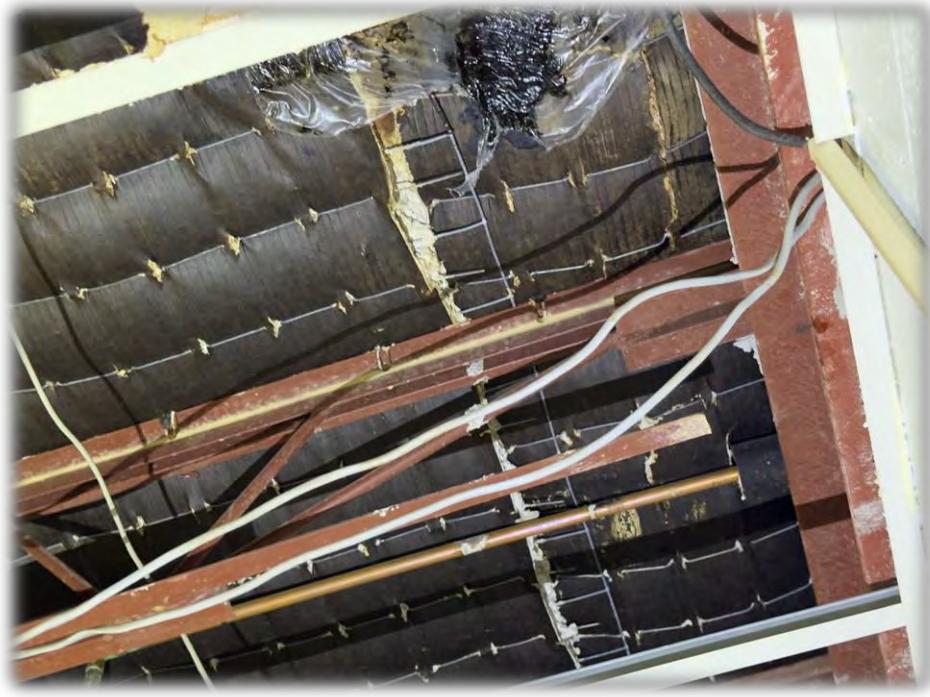
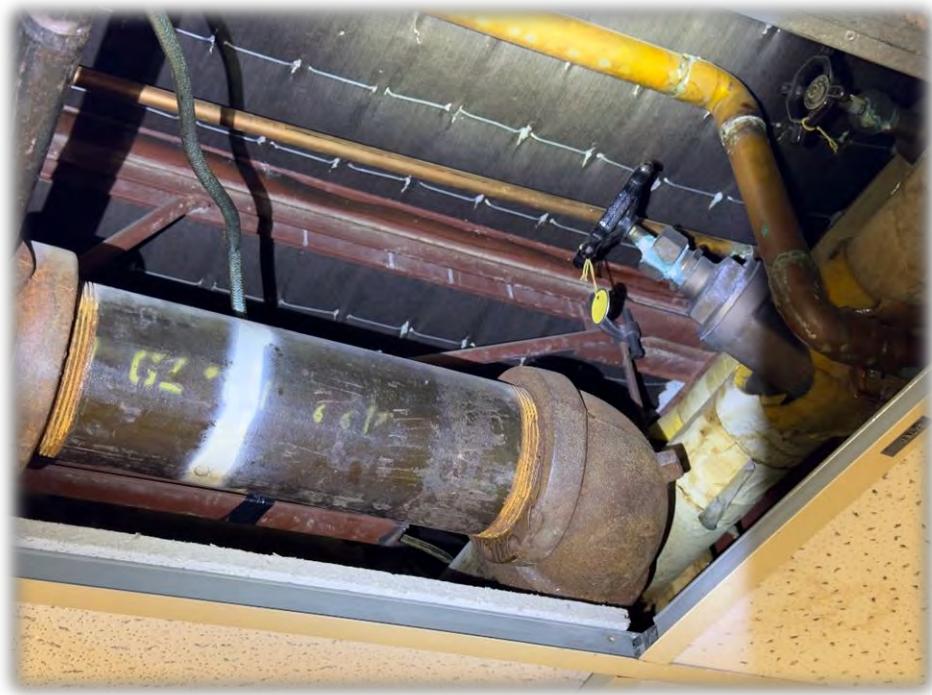
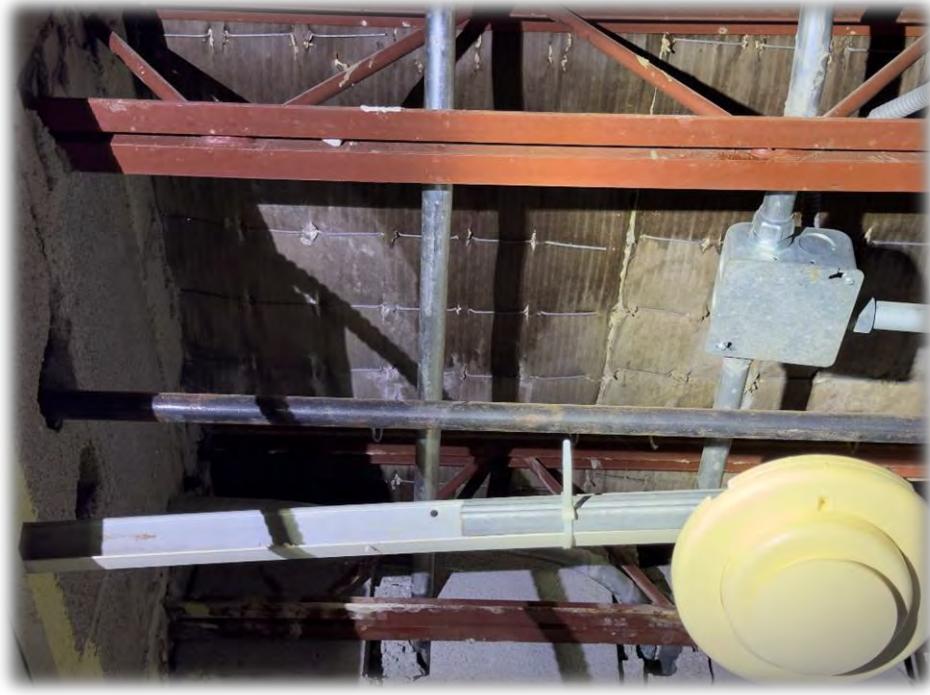
**Concrete Roof Deck** panels were noted in service beneath the standing seam metal roof areas of the Annex building, comprised of a wire reinforced thing form panel beneath the deck panels as seen in the series of photographs #14 through 18. These panels were set on the top chords of the bar joists and held in place with periodic heavy wire clips seen in photographs # 15 and 16.

The panels appear to be structural concrete panels as opposed to the more common gypsum or lightweight concrete panels based on the areas observed from the underside, without any facility to test the deck panels for compressive strength, which is not required at this time and may be performed as part of the future roof replacement project. The concrete panel roof deck assembly is in adequate condition without any apparent signs of deterioration and should be sufficient to accept the subsequent roof assembly which will more than likely require use a low rise adhesive grade urethane foam to attach the new insulation to the deck without penetrating the panels, which weakens the concrete deck panels via the series of drill penetrations. With two (2) roof systems in place, the exposed standing seam metal panels and the underlying BUR system atop the concrete roof deck panels, the future roof replacement will be a very costly venture involving removal of the standing seam metal roof panels, underlying steel roof panel support structure, vinyl clad insulation, aggregate covered BUR membrane and BUR insulation prior to installing new code compliant insulation.

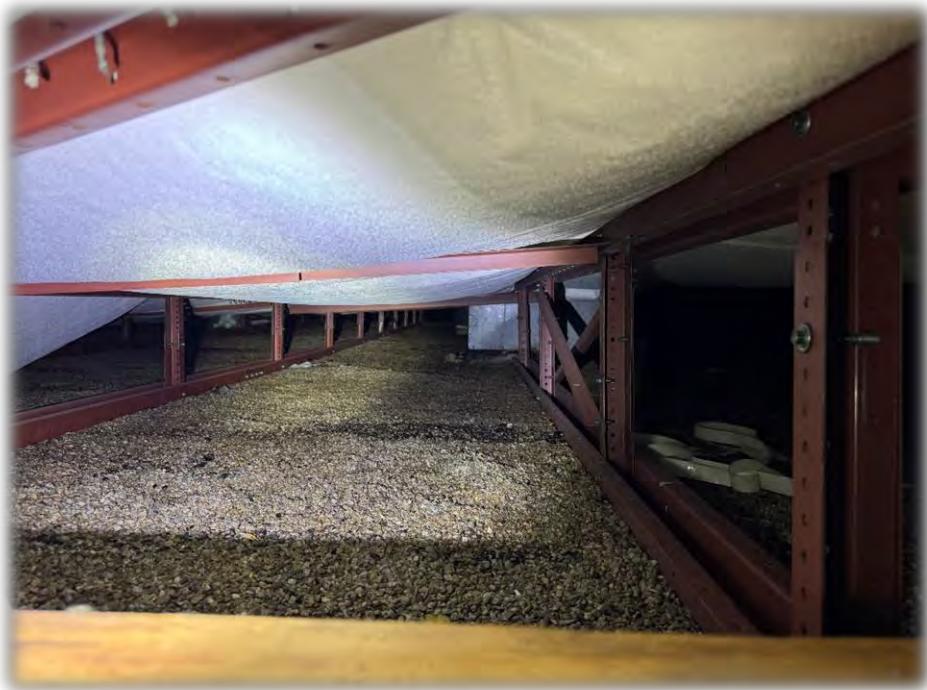
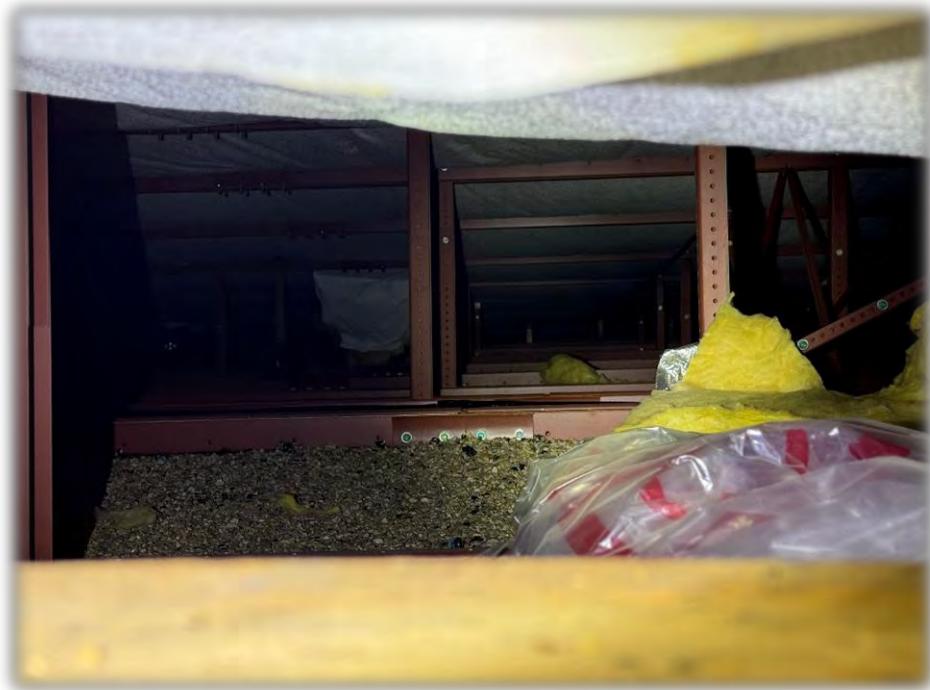
**Steel Support Structure** for the trapezoidal standing seam metal roof assembly is positioned atop the aggregate covered BUR membrane as shown in the series of photographs # 19 through 24. Due to tight dimensions of the accessway panel, actual inspection of the steel framework was unable to be performed in that enclosed space; however, it appears the steel framework and standing seam metal roof system may rely on dead weight to restrain the assembly atop the BUR assembly as there was no evidence of mechanical fasteners into or through the structural concrete roof panels. Such a scenario is unusual and comes with a degree of risk of uplift failure if exposed to severe wind loads such as associated with a microburst, derecho, or tornado. There is no remediation work to secure the steel structure in place at this time as such would be a costly venture, complicate eventual removal of the assembly to reroof the building and penetrations in the deck could easily compromise the panels. In addition, the loose laid metal roof assembly appears to have sufficient dead weight to restrain the framework and panels in place as evidenced by long term service. Note that such dead weight restraint of a metal roof assembly is neither common nor code compliant and may be supplementally secured to the structural concrete roof deck panels or to the top chords of the bar joists.

**Insulation** on the Butler standing seam metal roof assembly consist of vinal faced fiberglass that extends between the top flanges of the series of Zee purlins, held against the underside of the metal roof panels as seen in photographs # 19 through 24. Numerous sections of the insulation were encountered dislodged and hanging down onto the BUR membrane as seen in photographs # 23 and 24 with other areas notably bowed which creates a gap between the insulation and metal panel underside, allowing for condensation to form and drip onto the BUR surface providing the plenum is exposed to warm moist air that can condense on the cold underside metal panel surfaces.

The monolithic BUR membrane serves as an effective vapor barrier, limiting the condensation condition on these areas. Due to the age, condition and tight enclosed working conditions around the fiberglass insulation, there is no recommendation to address or remedy the missing and/or hanging insulation, all of which will eventually be removed and discarded as part of the eventual and future roof replacement project.

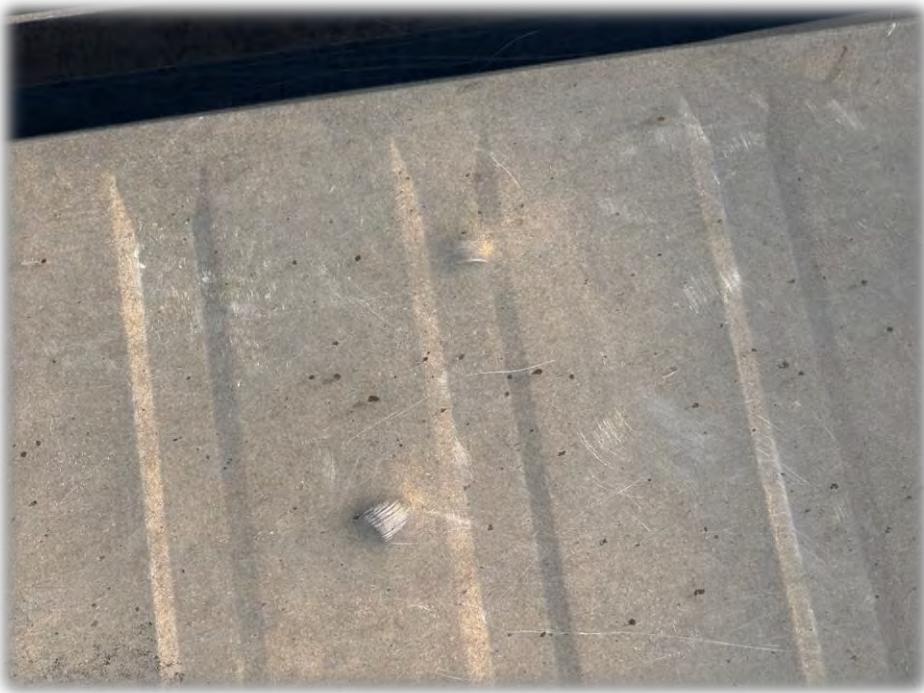
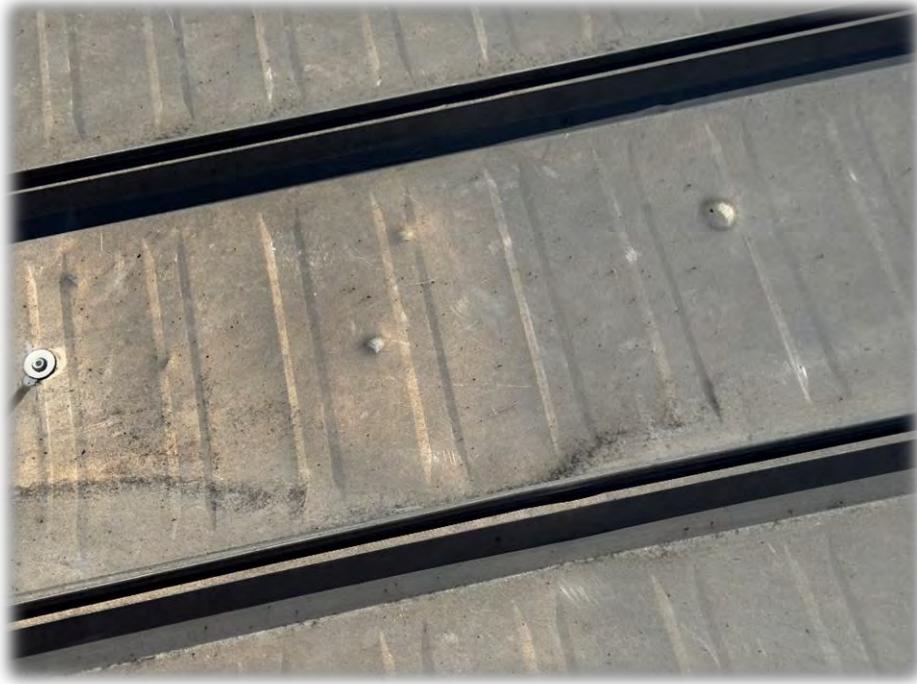
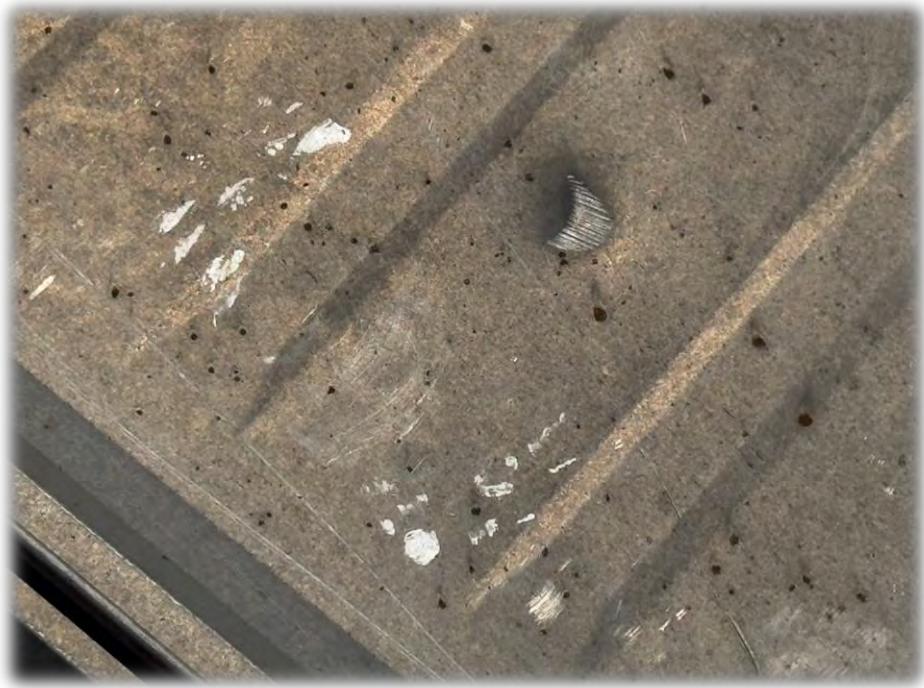
**Impact Damaged Panel Areas** were encountered about the metal roof assembly in no distinguishable pattern, with examples of the impact damaged area shown in the series of photographs # 33 through 41. At first glance the impact damaged areas could have been attributed to hail damage; however, with close observation of the dimple depressions, physical scrap marks can be seen such as in photographs # 37, 40 and 41. Hail impact dimples on a metal roof are circular not erratically shaped and do not have physical scrape marks, which indicates physical damage. These dimple depressions are not an imminent leakage threat but are commencing to experience surface rust as seen in photograph # 41, due to depressed surface areas holding water for a period of time after each precipitation event. The additional exposure to water while limited, takes a toll over an extended period of time. As it is the intent to maximize the length of effective service from this metal roof assembly, the impact damaged panel areas should be addressed with a skim coat of a solvent base flashing grade elastomeric which will bring the dimpled area flush with the metal panel surface and the solvent base elastomeric will neutralize the early stage oxidation process. Solvent base elastomeric materials specified for Northridge projects include; Truco Super Seam Seal, Topps RivetGard, Karnak Karna-Flex 502 Seam Sealer and GAF TopCoat SB-900. This work should be initiated within the next 12 months, coordinated with other metal roof restorative work items as outlined within this report. The cost for performance of the solvent base flashing grade elastomeric material within impact damage panel areas is estimated at **\$535.00**, reflecting five (5) man hours of labor at \$85.00 per hour along with a material allotment of \$110.00.

1.	<b>Apply Solvent Base Sealant In Impact Damage Dimples</b>	<b>Field Locate Impact Metal Panel Surface Dimples, Clean &amp; Fill Areas with Solvent Base Elastomeric</b>	<b>\$535.00</b>	<b>Within 12 Months</b>

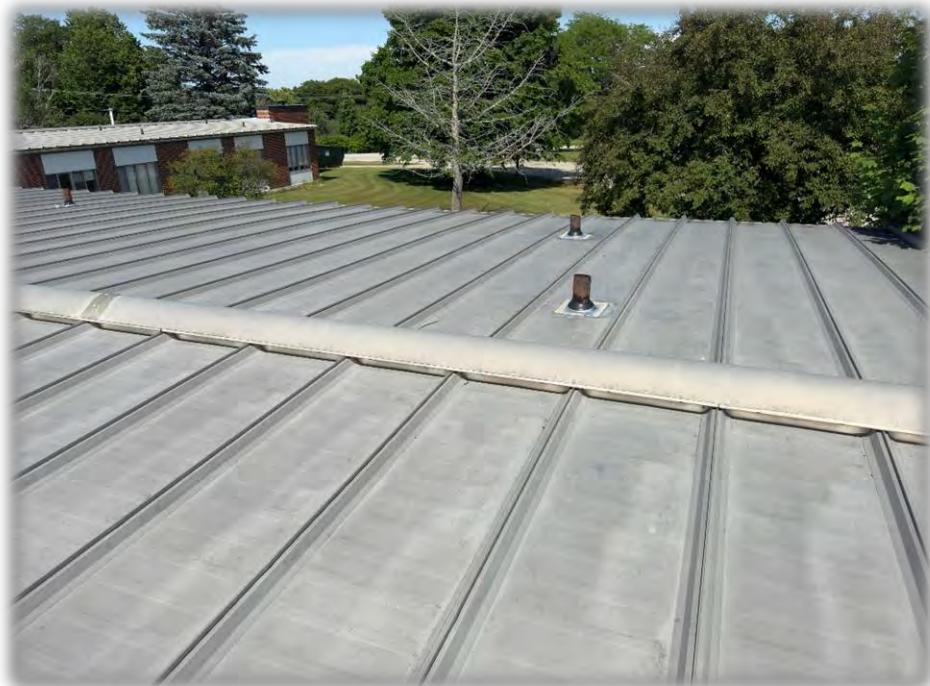
Photograph # 42 ⚡

**Ridgeplate Assemblies** on the Butler standing seam roof areas consist of an elevated bowed metal panel as shown in photographs # 42 through 47 with pop rivets along the lower edges of the bowed plate profile and within each transverse overlap seam. Beneath the ridgeplate assembly is a formed metal closure strip that remains tightly secured with sealant along edges of the baffle plates. As the sealant continues to age, dry out, crack and erode, a point of entry may be created for wind driven precipitation to enter the building. At that time, a dry tool bead of sealant should be applied along interface edges of the metal baffle and the metal panel surface; however, no such work is required at this time or anticipated to any degree over the next ~ 5 years. Despite the age of the sealant beneath this ridgeplate the sealant and metal baffles are protected by the ridgeplate overhang which moderates deterioration of these components.

Butt edges of the bowed ridgeplate assemblies are typically fitted with a rubber bellows style ridge cap which is absent on these roofs, rather the butt ends of the ridgeplates were overextended to offer protection to the recessed formed closure panels, as seen in photograph # 46. There is no dedicated restorative work effort for the ridgeplates, with any future leaks to be addressed at the direction of management with the cost deducted from phased leak repair allotments as outlined in a separate paragraph later within this report.

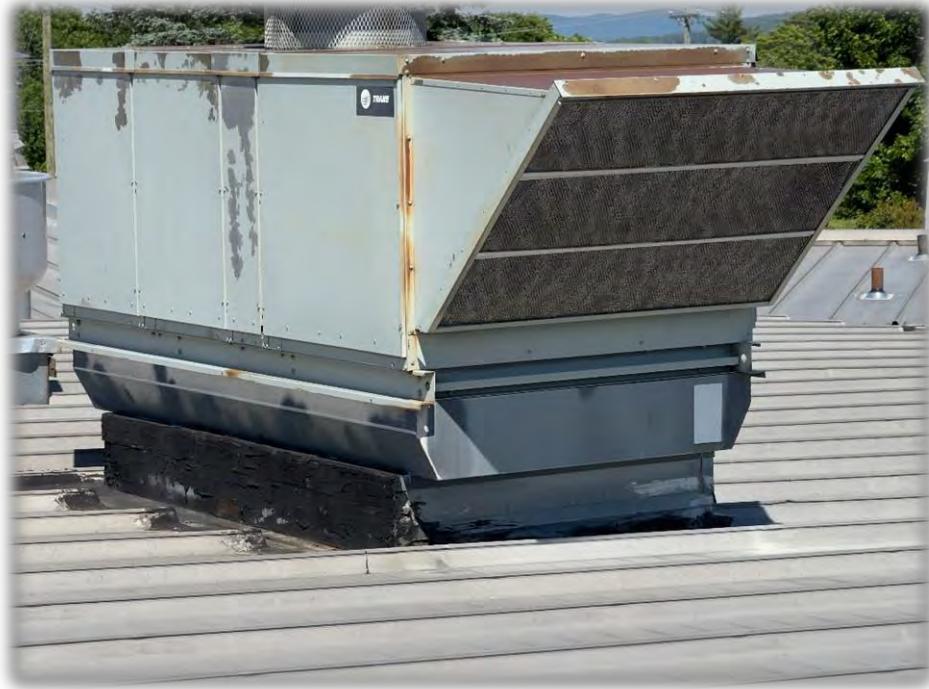
Photograph # 48 ⚒

**Mechanical Units** were located in two (2) areas atop the standing seam metal roof assemblies, with an example shown in photograph # 48 with locations and type of units identified on the scale Roof Plan. Cabinet surface rust is noted to be addressed by mechanical service personnel. Flashings at the curbed mechanical units consist of formed metal curbs augmented with what appears to be uncured EPDM flashing membrane in a fair condition. The flat profile top surfaces of the larger Rapid style heaters are in poor condition as seen in photographs # 101 and 102 with what appears to be latex acrylic coatings with widespread microbial growth and evidence of rust compromise of the thin gauge steel surface areas. Same as for the previously reviewed cabinet surface rust, such should be addressed by mechanical service personnel, independent of the roof assembly. Mechanical units appear to have sufficient curb height so as to accept a PVC flashing assembly without lifting the curbs.

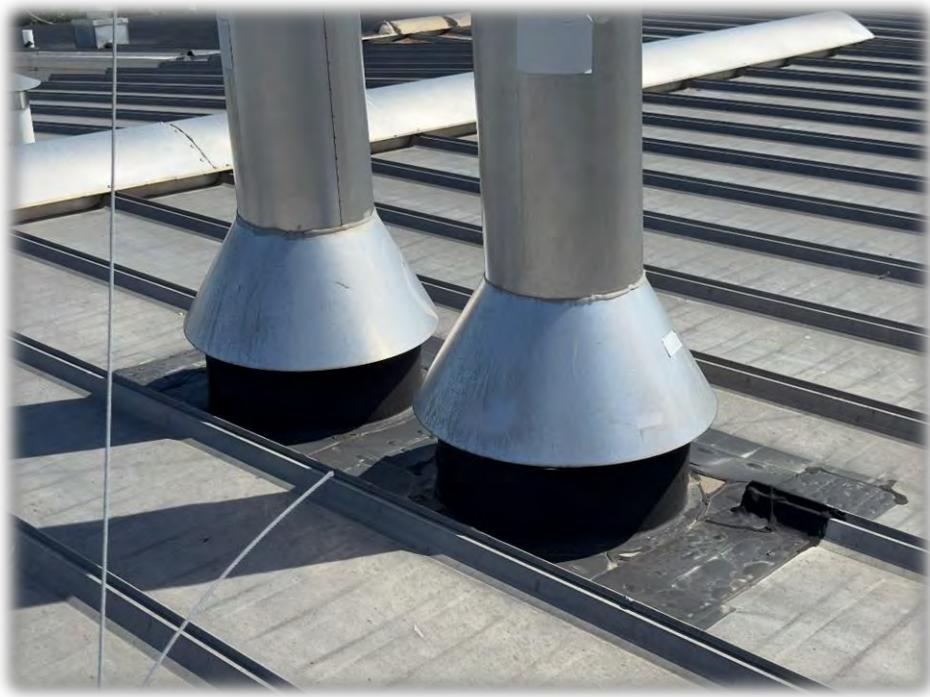
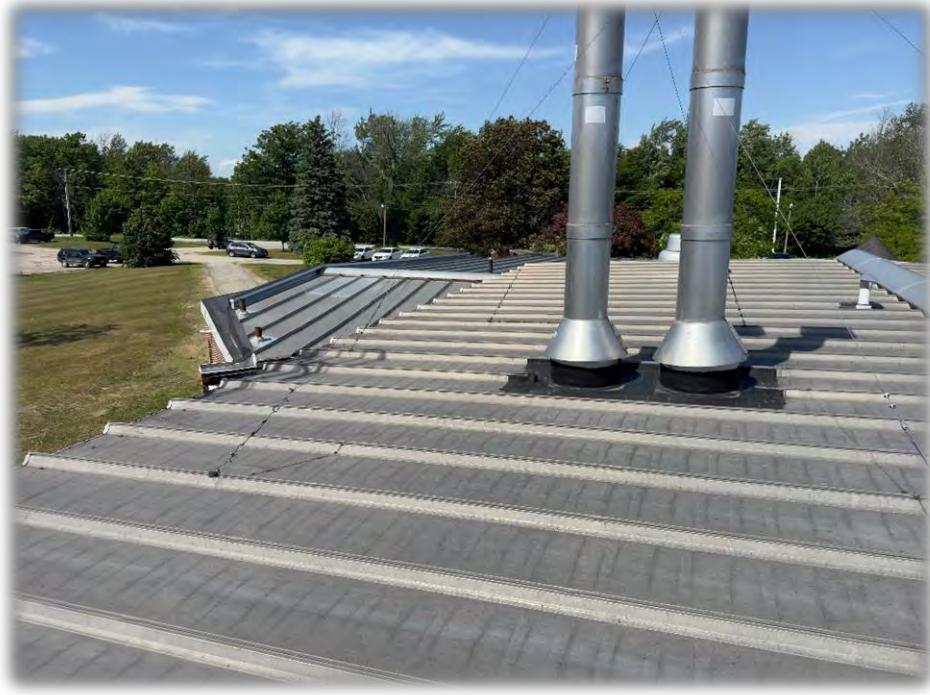
**Steel Chimney Stacks** were located in on the central portion of the West elevation of the Butler standing seam metal roof areas as identified on the scale Roof Plan and shown in photographs # 49 and 50. The chimneys are round, insulated steel assemblies that extend high above the metal roof surface as seen in photograph # 50. The stacks were flashed to the metal roof surface with uncured EPDM membrane as shown in photograph # 49 which is an acceptable flashing application and both chimneys were fitted with functional caps and storm collars. Due to the overall height of the steel chimneys, a series of guide wires was employed, secured through the top of standing seams after drilling a hole atop the vertical seam and fitting with screw pin clamps, through which the steel cables were run with a protective sleeve as seen in photograph # 51. Holes in the standing seams are not optimal but away from sheet drainage and only be a risk for leaks during periods when covered with by frozen precipitation. With the clamp areas covered with sealant, there is no recommended restorative work for these areas. For reference, securing any equipment to a metal roof system should employ the proper S-5 clamp, of which there are many different sizes and configurations with an example provided in the image to the right.

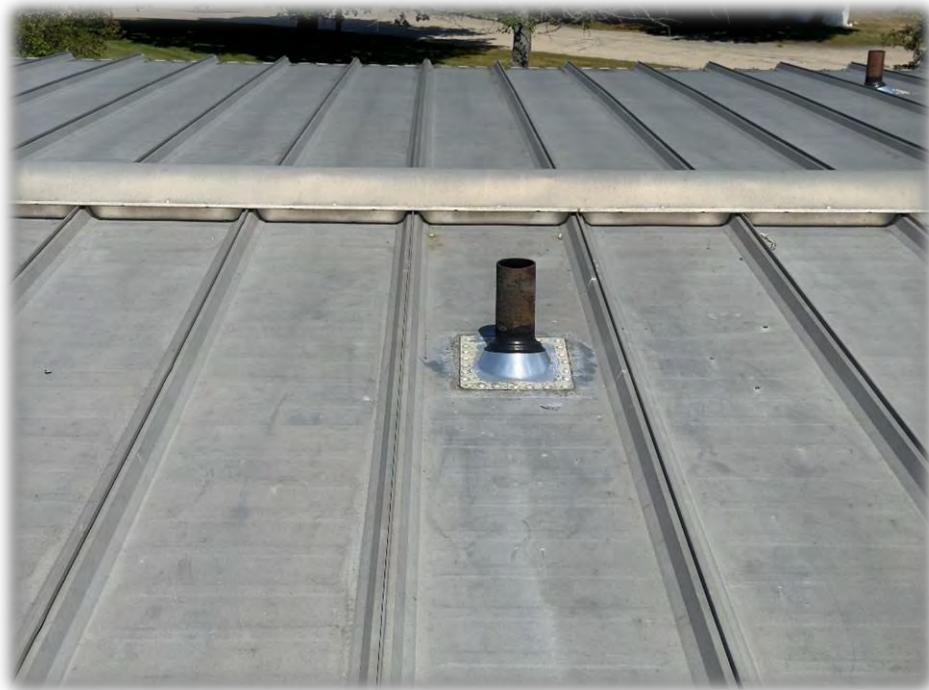
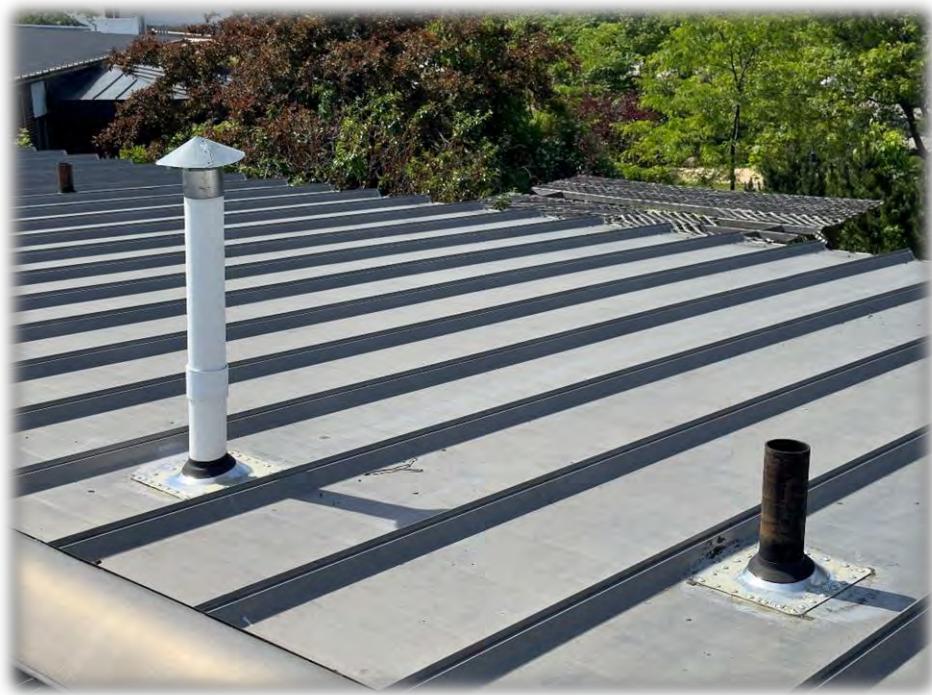
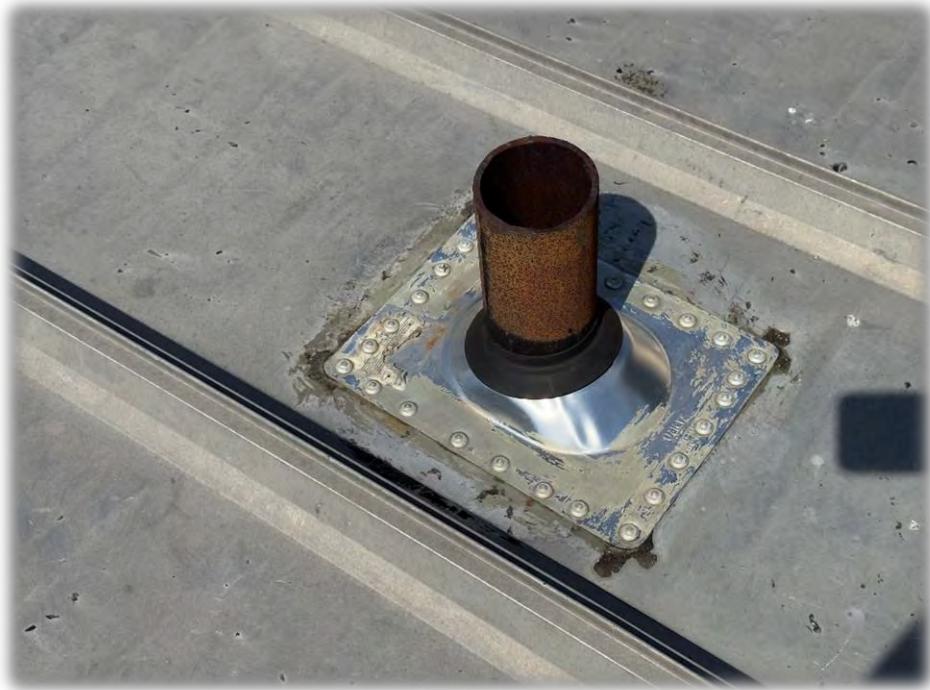
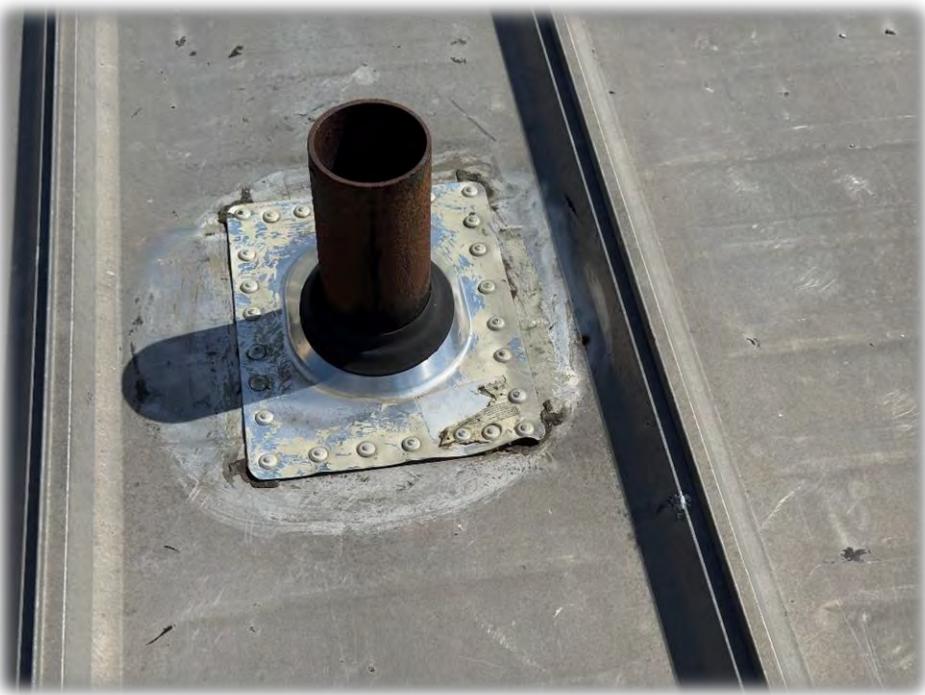
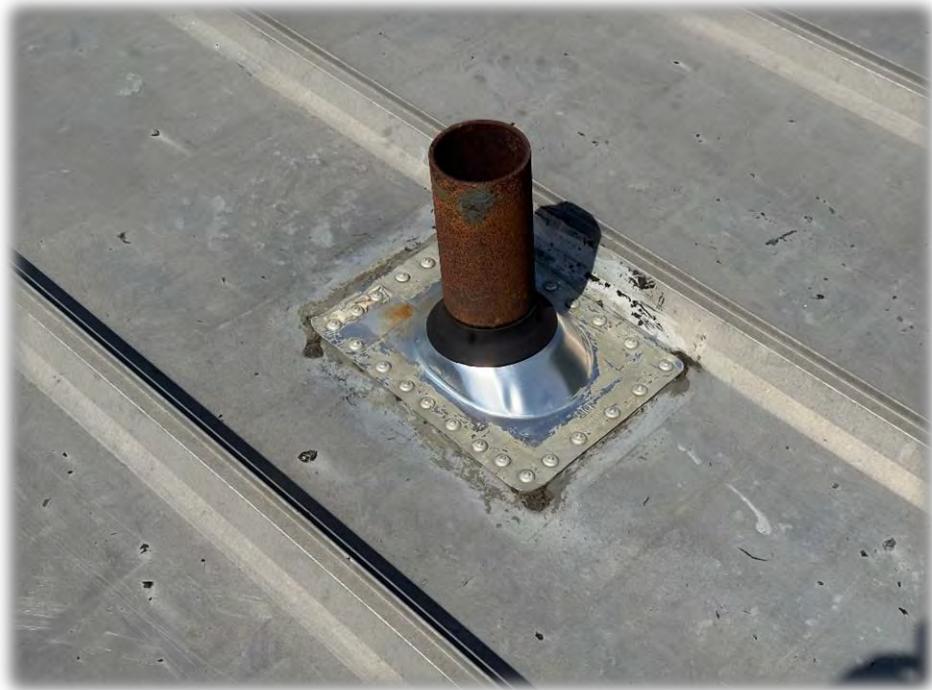
**Vent Pipe Penetrations** were located about the Butler trapezoidal standing seam metal roof assemblies flashed with residential style molded boots set within metal flanges as seen in photographs # 52 through 58. The watertight integrity of these flanges relies on sealant under tension between the metal plate and the roof panel as well as the tension seal; between the vent pipes and the top of the molded boots. Based on the number of sealant applications at the pipe boot flashings, it appears they have been less than effectively watertight. Same as for the gas flues reviewed later in this report, the flanges should be covered with a suitable flashing membrane that encapsulates the exposed fasteners and flange edges to ensure a watertight service for an extended period of time estimated at 8+ years. For reference, pipe vents on a metal roof should be fitted with a suitable boot set in sealant and secured with a series of EPDM washer stainless steel screw fasteners through the lower flashing ring into the metal panel with a stainless steel clamp ring atop the boot with an example of such provided in the image to the right for reference. Once the existing pipe vent were fitted with the residential pipe boot flanges, the option to install a proper commercial boot was eliminated as the oversized flanges of the residential boots that are designed to be installed under asphalt shingles, interfere with the round commercial boot installations. The recommended single ply membrane re-flashing has membrane options that include EternaBond AlumiBond and MFM Peel and Stick, both with reflective aluminum foil facers and cross-link polymer films that are easily applied atop cleaned and primed metal surfaces and very malleable, suitable to be hand molded around protruding fastener heads and over flange step off edges. A narrow strip of the membrane may be employed around the pipe vent interface with the molded boots to ensure effective watertight service. This recommended pipe vent flashing work should be initiated within the next 12 months to allow pipe vent penetrations to provide an additional 8+ years of effective watertight service. The cost for the pipe vent penetration re-flashing work is estimated at **\$1,875.00**, reflecting eighteen (18) man hours of labor at \$85.00 per hour with a material cost of \$345.00.

2.	<b>Re-Flash Pipe Vents With Foil Face Peel and Stick</b>	<b>Prep Pipe Vent Flanges to Remove Sealants, Re-Flash With Foil Face Peel and Stick Flashing Membrane</b>	<b>\$1,875.00</b>	<b>Within 12 Months</b>
