# Roof Condition Report

Documentation, Analysis and Recommendations for  
the Standing Seam Metal and EPDM Roof Assemblies

Carroll County  
Annex Building  
10 County Farm Rd  
Ossipee, NH 03864

June 26, 2024

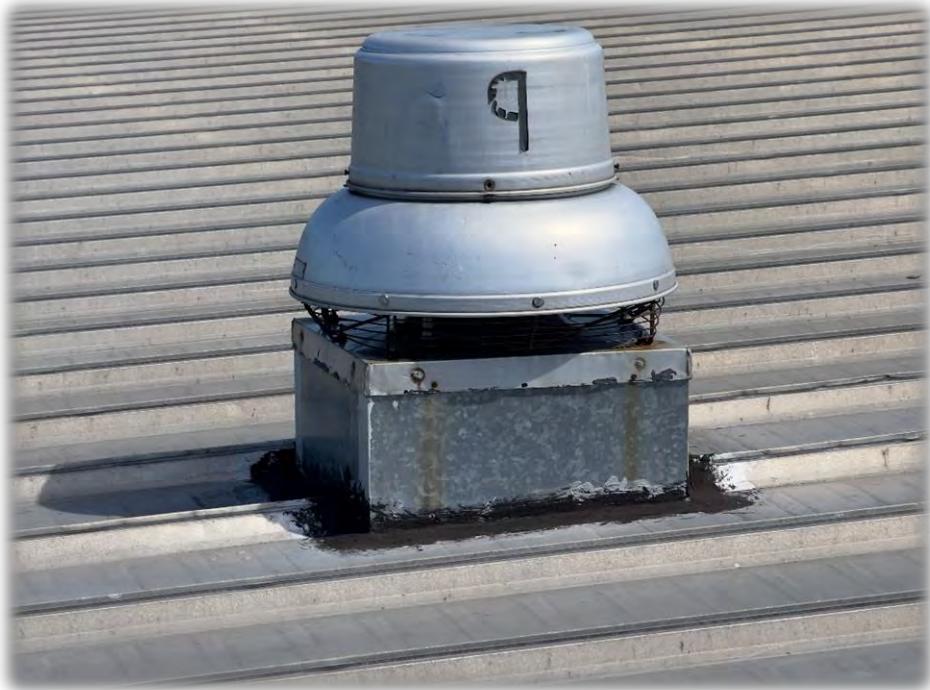
Photograph # 60

**Exhaust Curb Penetrations** as located about the Butler standing seam metal roof assemblies are noted on the scale Roof Plan on Drawing A – 1 with examples shown in photographs # 59, 60, 61, 62 and 63. Each of the curb penetrations were previously flashed with asphalt mastic which is not a proper material for use on a metal roof system and if left in service, will eventually leak as the difference in coefficients for thermal expansion between the non-compatible materials will create a shear plane that allow drainage to pass beneath the asphalt and result in active leaks and rust compromise of the areas exposed to leakage.

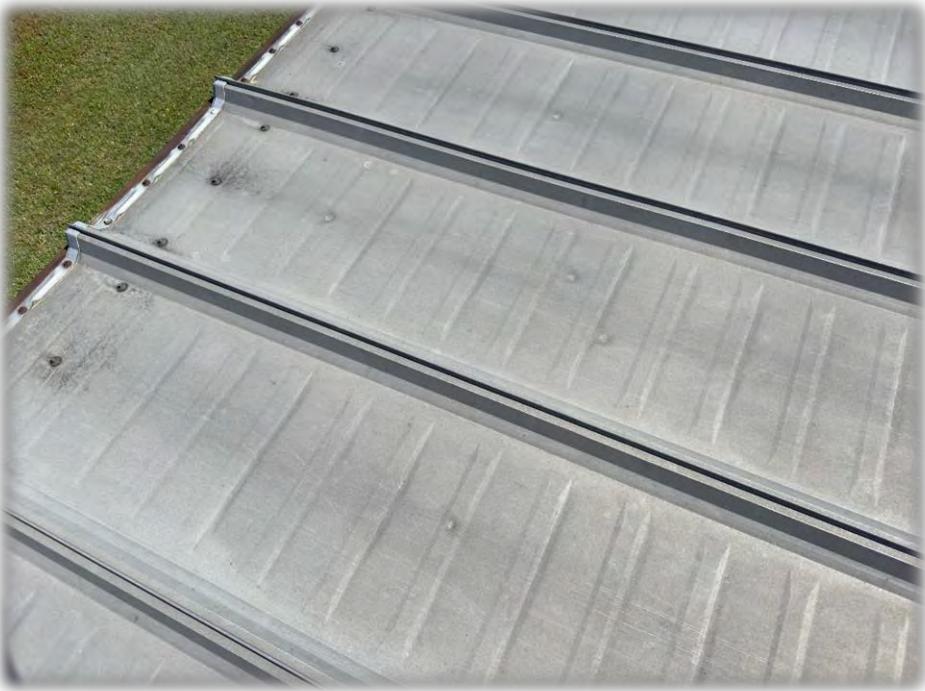
Photograph # 71 ⚡

**Lower Panels** were encountered with a formed Butler batten along the edges as seen in the series of photographs # 69 through 74 without any instances of rusting or failed battens noted. The lower sections of the metal panels have screw fasteners through the panels as seen in photographs # 73 and 74, a percentage of which have been replaced including some with what appear to be proper stainless steel fasteners with an integral washer and flange while others were replaced with a standard screw fasteners and standard flat washers which is not an acceptable assembly as the interface between the flange on the screw fastener and the flat washer is not watertight. Such fasteners may properly function in light precipitation but in periods of heavy precipitation and exposure to snow and ice, the fasteners will leak water into plenum between the metal roof and underlying BUR assembly. In order to proactively address the substandard replacement fasteners, such should be field located, removed and replaced with oversized stainless steel EPDM washer fasteners, a diagram of which is provided to the right of this text for reference.

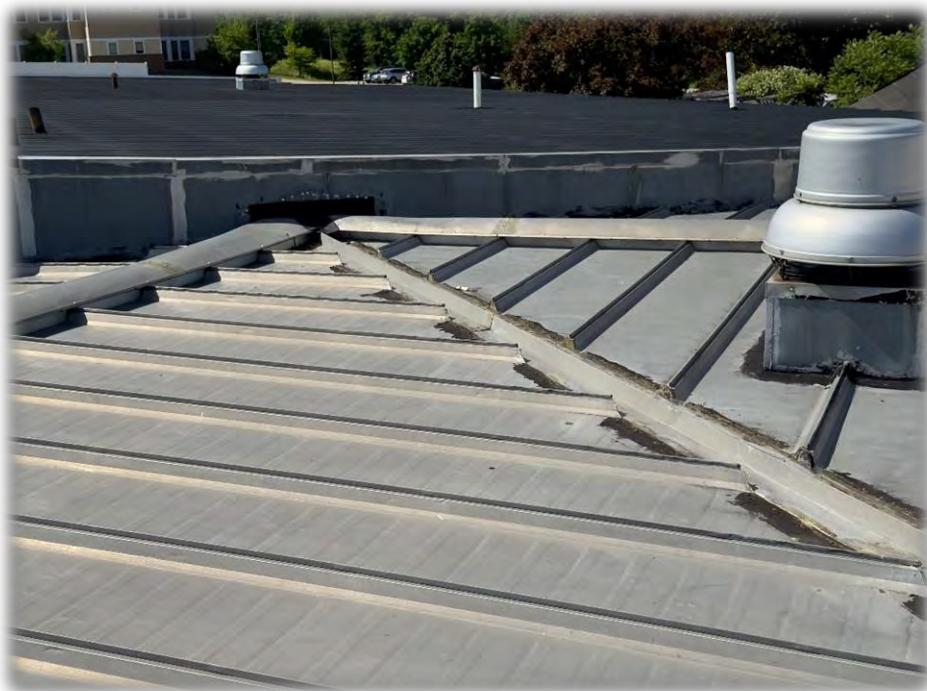
Photograph # 76 ⚡

**Valley Gutter** was encountered between separate metal roof areas in the East central section of the building as seen in photographs # 75 and 76 and noted on the scale Roof Plan. Such valley gutter channels are not optimal on a metal roof assembly but necessary in select construction environments. The lower metal panels are not fitted with formed batten as the lower panel edges are, due to the elongated angular cut of the channels between the raised standing seams. The recessed gutter channel should be sufficient to accommodate sheet drainage without issue as the size of the metal panels above the valley gutter is limited. If the metal panel areas were larger, the flow of sheet drainage could in a heavy precipitation event, impact against the opposite drainage flow and splash back on the lower panel edges. The lower panel edges against the valley gutter has already been addressed with asphalt flashing cement, indicating a prior issue along this area. The recommendation is for the lower panel edges on both sides of the valley gutter to be proactively flashed with foil face peel and stick membrane, ~ 1/2" from edge of the gutter to 2" past the edge of asphalt.

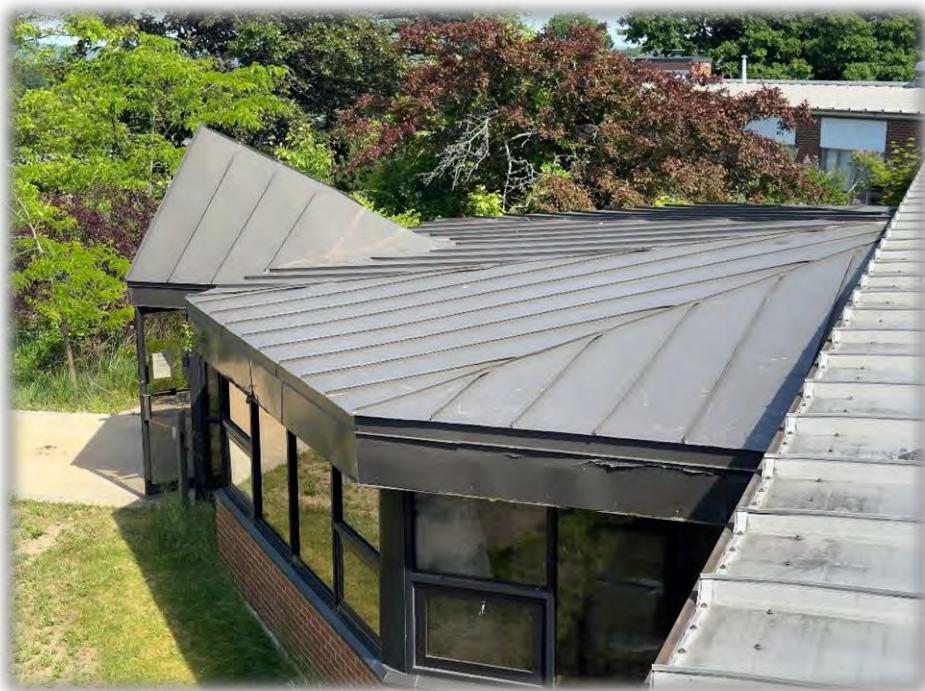
Photograph # 80 ⚒

**Overviews** of the unidentified standing seam metal roof assembly atop the front entranceway as shown in photographs # 80 and 81 and noted on the scale Roof Plan. This metal roof area measures off at ~ 822 sq ft and includes a raised dormer over the front doorway to shed snow and ice away from the passageway. The metal roof is a vertical leg style assembly as diagrammed to the right in contrast to the trapezoidal standing seam assembly on the main building. The vertical leg standing seam metal panel securement was free of exposed fasteners with the lower panel edge folded over onto the underlying panel. There is no direct access to the entranceway roof surface.

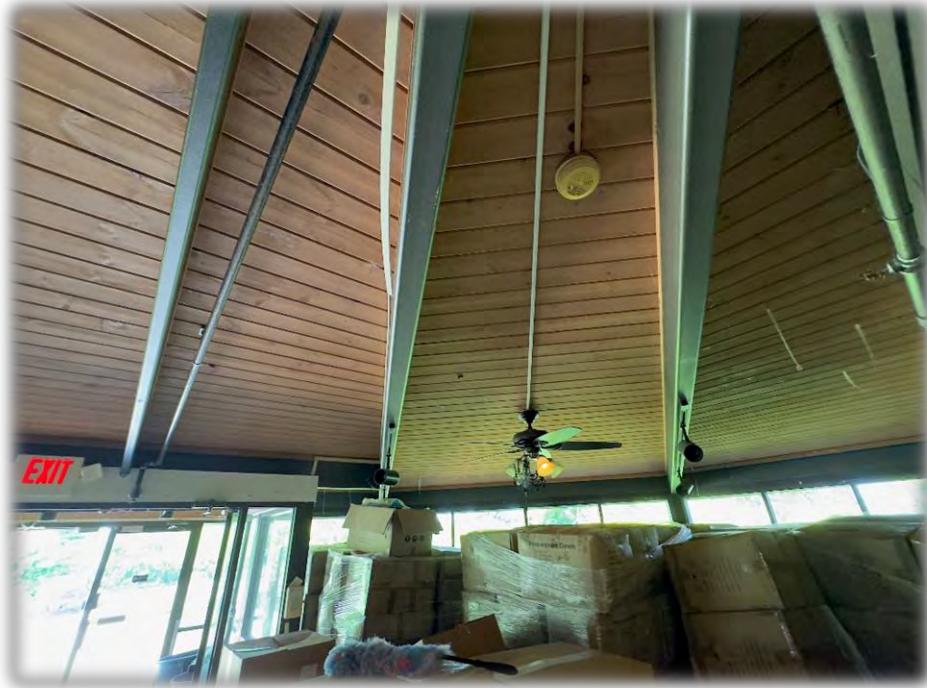
Photograph # 82 ⚡

The interior of the entranceway metal roof assembly was inspected with views of the steel support members and what appears to be tongue and groove wood planks shown in photographs # 82, 83 and 84. There is no evidence of fasteners through the wood decking panels which tends to indicate the brackets and tabs for the vertical leg standing seam metal roof were secured into the wood planking. A review of leakage conditions on this angular metal roof entranceway roof area was conducted with Annex management who indicated the steeper slope metal roof is effectively watertight which is not surprising considering the slope and absence of penetrations. Drainage from this entranceway metal roof area is allowed to free fall off the lower edges.

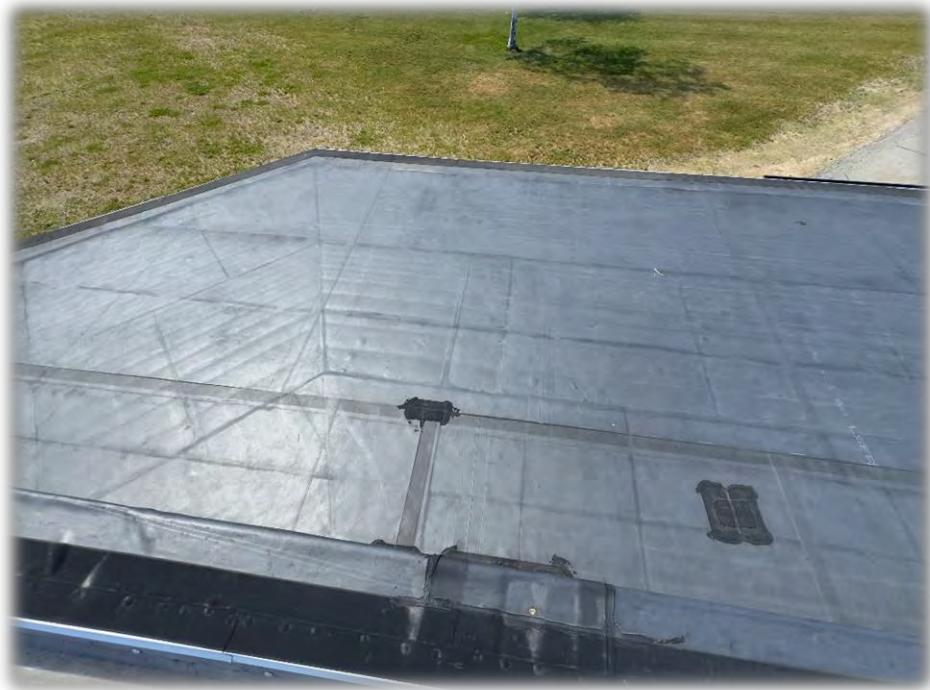
Photograph # 86 ⚡

**Overviews** of the adhered EPDM roof system atop the designated areas of the Annex building are shown in photographs # 85, 86, 87 and 88 for that larger section of roof along the West elevation of the building, shown on the scale Roof Plan. This roof area measures ~ 494 sq ft and appears to have been installed as part of the Annex building modification that saw demolition of the West elevation angular wing areas. The manufacturer of the EPDM roof system is unknown. The adhered EPDM roof membrane appears to be 60 mil installed atop a stratum of assumed polyisocyanurate insulation, without any penetrations and with butyl tape used in the seams. The EPDM roof membrane was extended up the vertical wall leading to the metal roof assembly as seen in photographs # 87 and 92. There were two other small fully adhered EPDM roof areas noted during the inspection, as seen in photographs # 89, 90 and 91 with the areas noted on the Key Plan and scale Roof Plan on Drawing A – 1. Drainage is allowed to free fall off the lower EPDM roof edges except for the East elevation area noted in photograph # 91 which is fitted with a gutter channel. For general reference, a diagram of a fully adhered EPDM roof assembly is provided to the right of this text for general reference showing a mechanically secured polyisocyanurate roof insulation layer atop a corrugated steel deck with the EPDM membrane adhered to the insulation facer with a vapor barrier. The deck on the larger EPDM roof area rests atop newer composite deck panels shown in photographs # 93, 94, 95 and 96. The adhered EPDM roof systems may be covered under Warranty which is typically issued for 10 or 15 years; however, without penetrations, use of butyl seam tape and a quality installation, no leaks are anticipated on these EPDM roof assemblies for the next ~ 5 years.
